FIRE SAFETY PERFORMANCE OF MOTOR VEHICLES IN CRASHES

Kennerly H. Digges¹
R. Rhoads Stephenson¹
Paul G. Bedewi²

¹Motor Vehicle Fire Research Institute (MVFRI)
²FHWA/NHTSA National Crash Analysis Center –
The George Washington University
USA
Paper Number 422

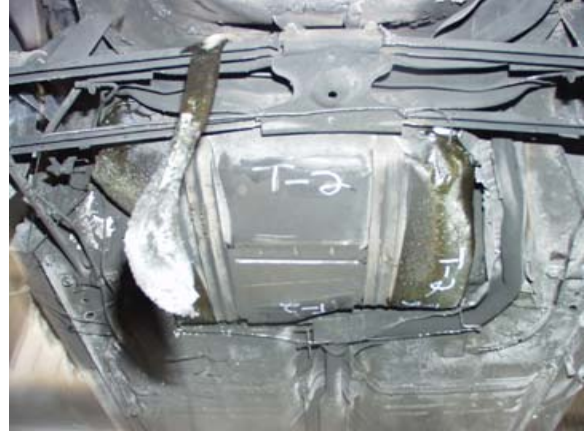
Figure 14. "Pancake" tank after fire test.

Other observations made from the tests included the location and size of the initial leak that occurred before the fire was extinguished. The two pancake tanks leaked at the same place – the bottom left rear corner. In both cases, the leaks were very small. The two square tanks both leaked in locations that were associated with loading by the mounting strap. Both tanks also leaked or were severely weakened at the front right top corner due to sagging of the tank. The rate of leakage from the square tank was greater than for the pancake tank. The two long tanks both leaked due to sagging of the front part of the tank that overhung the mounting straps. The leakage occurred at the front of the tank or at the straps. The rate of leakage was greater than the square tank. The post test deformation of the “pancake” tank, the “long” tank, and the “square” tank are shown in Figures 14 through 16.

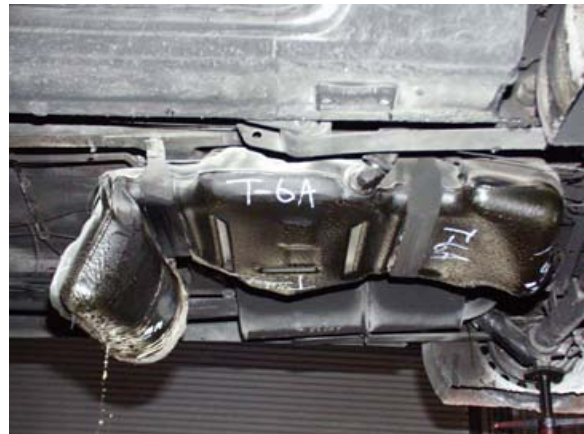
Figure 15. "Long" tank after fire test.

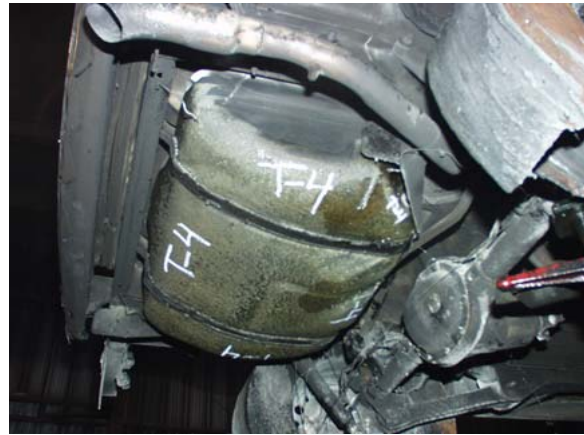
Figure 16. "Square" tank after fire test.

other vehicles suffered less degradation and were not rebuilt. The second test of the “square” tank resulted in tank leakage at 101 seconds – 19 seconds short of the requirement. This difference could be explained by the increased ventilation permitted by the test buck.

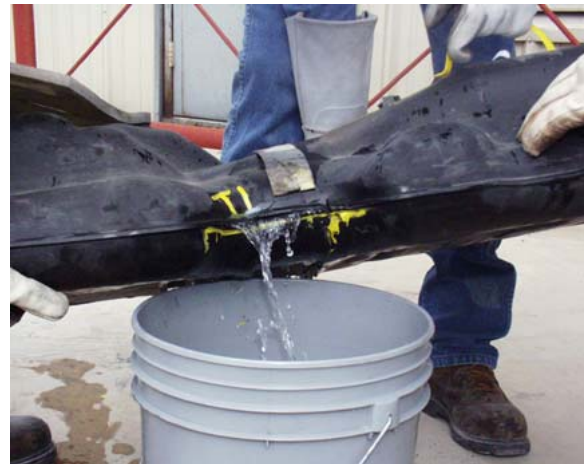
The results of the 30 ft drop tests are shown in Table 4. All of the new tanks and the seasoned pancake tank passed the test. However, both of the other seasoned tanks ruptured at the pinch-off separation. A typical breach of the tank is shown in Figure 17.

Figure 17. Seasoned “Long” Tank Post Drop Test

All three new tanks performed satisfactorily when subjected to the Federal Motor Carrier Safety Regulation CFR 393.67 (e)(1) 30 ft. drop test. However, the seasoned “long” and “square” tanks leaked excessively after the drop. This result suggests some degradation of the resistance to severe impact with aging for these tanks.
