MVFRI RESEARCH SUMMARY

Fire Exposure, Impact Tests, and Finite Element Modeling of Plastic Fuel Tanks

Based on contracts with:
Southwest Research Institute
Dr. Nabih Bedewi

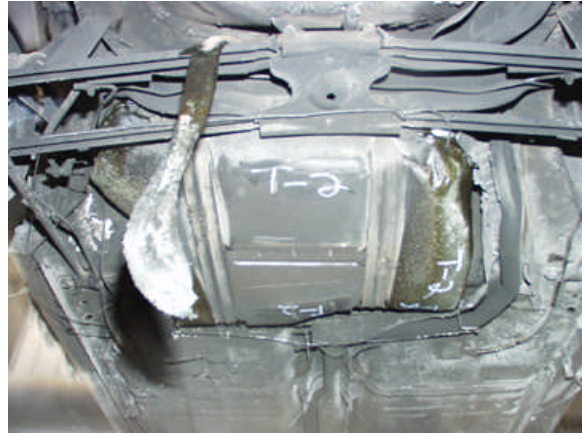
Figure 4. "Pancake" shaped tank post-test.

Other observations made from the tests included the location and size of the initial leak that occurred before the fire was extinguished. The two pancake tanks leaked at the same place – the bottom left rear corner. In both cases, the leaks were very small. The two square tanks both leaked in locations that were associated with loading by the mounting strap. Both tanks also leaked or were severely weakened at the front right top corner due to sagging of the tank. The rate of leakage from the square tank was greater than for the pancake tank. The two long tanks both leaked due to sagging of the front part of the tank that overhung the mounting straps. The leakage occurred at the front of the tank or at the straps. The rate of leakage was greater than the square tank. The post test deformation of the “pancake” tank, the “long” tank, and the “square” tank are shown in Figures 4 through 6.

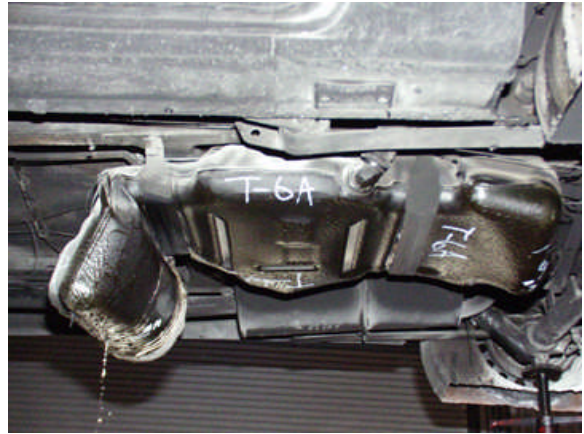
Figure 5. "Long" shaped tank post-test.

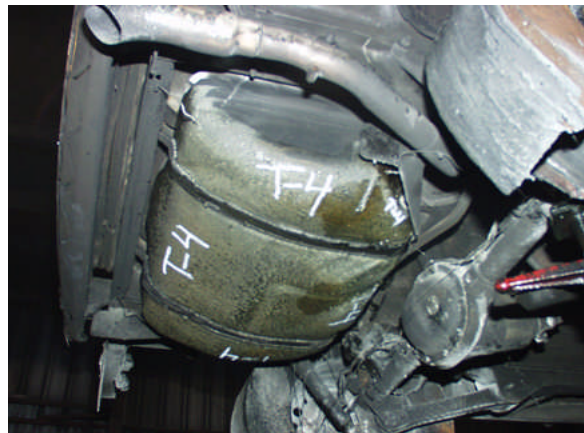
Figure 6. "Square" shaped tank post-test.

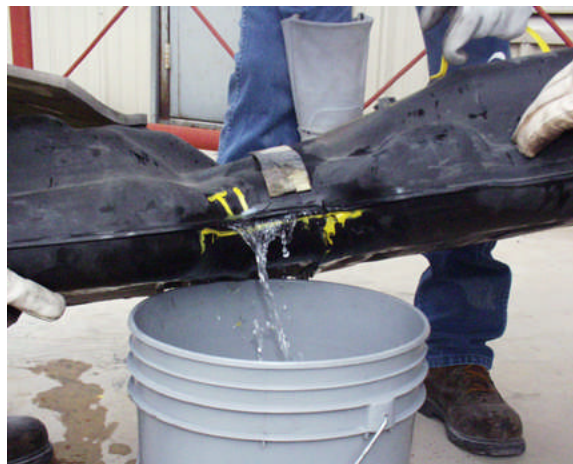
The results of the 30 ft drop tests are shown in Table 2. All of the new tanks and the seasoned pancake tank passed the test. However, both the long and the square seasoned tanks ruptured at the joining seam or “pinch-off”. A typical breach of the tank is shown in Figure 7.

Figure 7. Seasoned “long” tank post drop test

All three new tanks performed satisfactorily when subjected to the Federal Motor Carrier Safety Regulation CFR 393.67 (e)(1) 30 ft. drop test. However, the seasoned “long” and “square” tanks leaked excessively after the drop. In all cases the tank breach occurred at the joining seam or “pinch-off”, as shown in Figure 7. This result suggests some degradation of the seam to resist severe impact with aging.

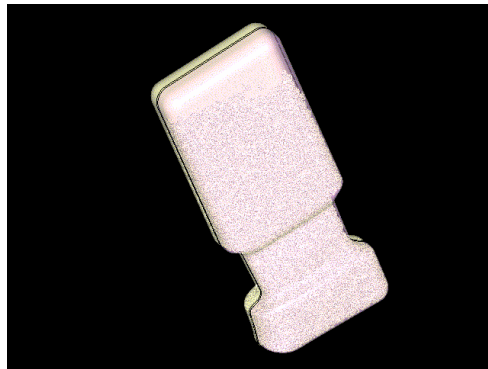
Figure 10 – FEM model of the rectangular tank

Figure 10 is a the FEM representation of the rectangular tank shown in Figure 8. It may be noted that the tank cross-section is not a pure rectangle, but contains a neck. The presence of the neck influences the stress on the pinch-off.

1. The FE analysis predicted the maximum loads near the same location where the pinch-off region ruptured in both the rectangular tank and square tank tests.
2. The presence of a neck section in a rectangular tank, keeping everything else similar, increases the forces in the pinch-off region by 50%.
3. Based on the estimates in Figure 9, the square tank pinch-off contact area is 30% of the rectangular tank pinch-off contact area. Therefore, for the same amount of force, the strength of the joint would be a third of the strength of the rectangular tank. Differences in the pinch-off joint can have a large influence on the burst strength of the tank.
