MVFRI RESEARCH SUMMARY
Kennerly H. Digges, Edmund Fournier

Survey of the State-Of-The-Art in Fuel System Fire Safety

Based on contract with:
Biokinetics and Associates, Ltd.

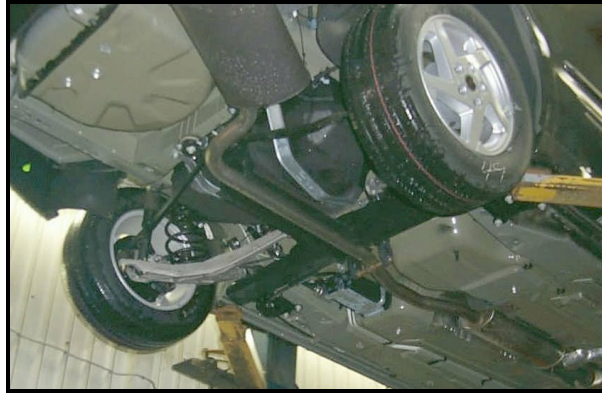
Figure 1 - Typical over the axle tank placement

All six tanks that were situated over the axle, extend both forward and aft of the axle and were somewhat centered about the medial plane of the vehicle. Although extending towards the rear of the vehicle, the distance from the tank to the rear bumper was maintained between 91 cm to 108 cm, except for one vehicle that had a tank clearance distance of 58 cm from the rear bumper. A typical over the axle tank placement is shown in Figure 1.

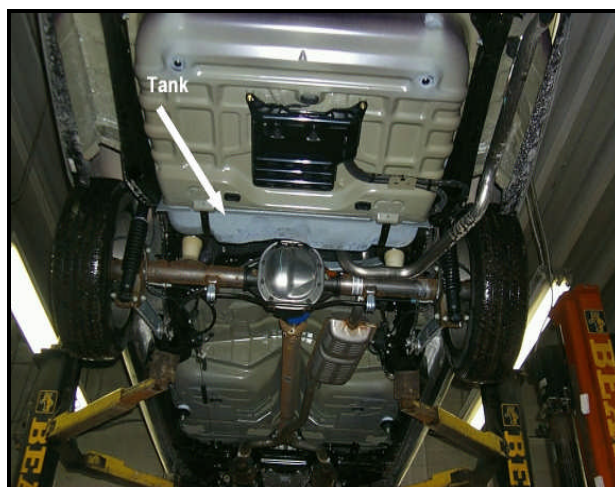
Four of the 74 vehicles inspected had their tank situated behind the rear axle. However, of the four, one was installed vertically which allowed for a large clearance of 97 cm from the rear bumper. This clearance is similar to that of the tanks that were located above the axle and to some of the tanks installed ahead of the axle.

Figure 2 - Behind-the-axle placement of the vertically mounted tank

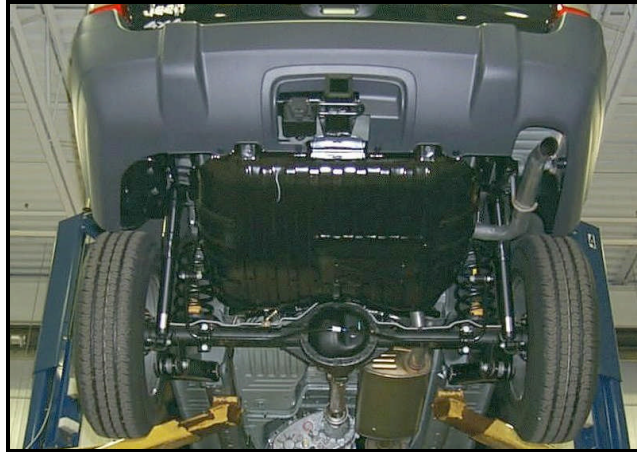
Fuel tanks from the other three vehicles essentially extended to the rear bumper. These vehicles maintained a tank distance between 29 cm and 31 cm from the rear bumper. The placement of the vertically mounted and a typical behind-the-rear-axle horizontal mount are shown in Figures 2 and 3.

Figure 3 - Behind-the-axle placement of the horizontally mounted tank

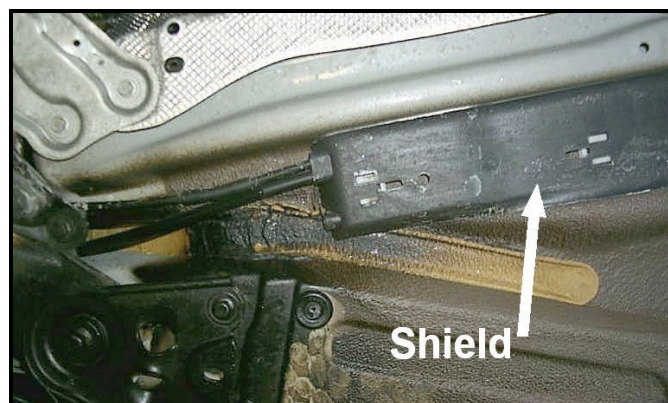
Fuel Line Routing and Shielding - In all the vehicles the fuel lines were predominantly made of steel and were generally routed such that they derived protective benefits from a vehicle's structure. Typically, the fuel lines were routed along a frame rail or unibody frame rail. To varying extents, supplemental shielding of the lines afforded additional protection in 28 of the 74 vehicles inspected. An example of partial shielding is shown in Figure 4.

Figure 4 – Partial fuel line shielding

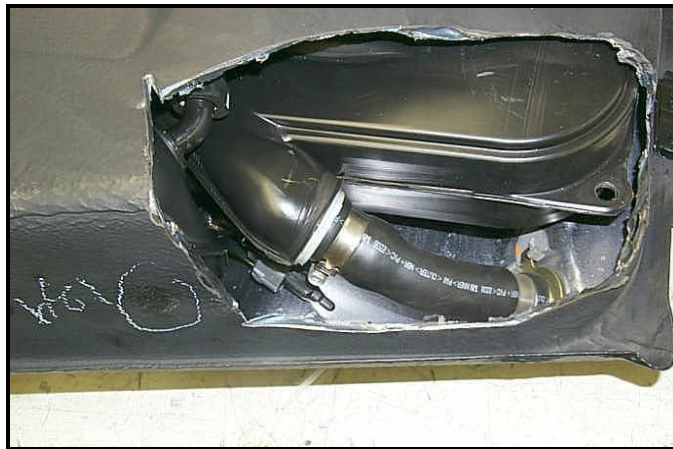
Tank Materials - Either plastic or steel are the materials of choice for the fabrication of fuel tanks. The incidence of their use in the 74 subject vehicles is presented in Table 4. Referring to Table 4, one vehicle's tank was classified as being fabricated with a combination of plastic and steel. The fuel tank is fabricated with a steel outer shell and an internal plastic tank as shown in the cutaway view of the tank in Figure 5.

Figure 5 – Cutaway view showing the plastic tank inside the outer steel shell

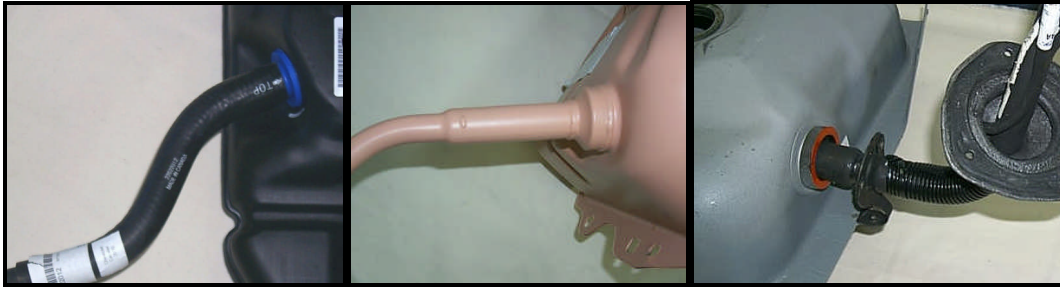
Filler Tube Connection - The filler tube connection to the tank was classified as positive, integral, or loose. In a positive connection the filler tube is mechanically fastened to the tank. An integral filler tube is molded simultaneous with the tank or welded on. With a loose connection, the filler is not mechanically fastened or integral with the tank. The filler tube itself was further classified as flexible or rigid. Examples of these connections are shown in Figure 6. The type of filler tube connection is summarized in Table 9 for the 18 tank inspections.

Figure 6 - Examples of (a) positive/flexible (b) integral/rigid and (c) loose/rigid filler tube connections to the fuel tank
