Cone Calorimeter Testing of Under Hood Insulation

R05-13 b

2005 – 08 – 23

This report constitutes the final deliverable for the Motor Vehicle Fire Research Institute's purchase order dated May 24, 2005 to investigate the fire retardant properties of under hood insulation.

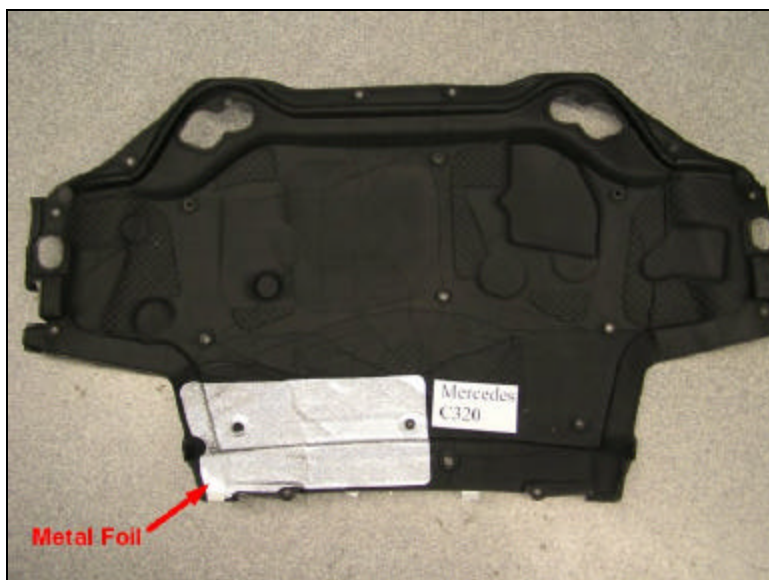
Figure 5: Replacement Under hood insulation for the Mercedes C320.

A section of the Mercedes C320 under hood insulation was covered with a metal foil as shown in Figure 5. Interestingly, unlike the replacement liner that was purchased for the cone testing, there was no foil present in C320 vehicle that was inspected. In examining the engine compartment there was no apparent reason for the use of the foil (see Figure 6). Nevertheless, to evaluate the effect of the foil, insulation samples from both the fibre exposed and foil exposed surfaces of the liner were tested (test 15A and 15B respectively). Similarly to the Ford Ranger tests, the foil covered surface did not ignite whereas the exposed insulation ignited in 11s. These findings suggest that the application of a metal foil to the insulating panels can be used to prevent material ignition.

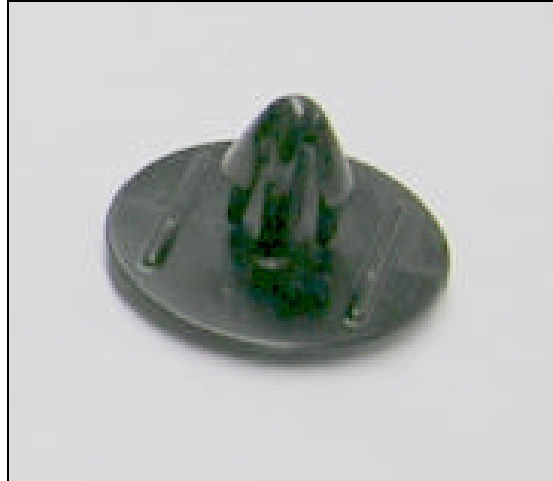
Figure 8: Insulation clip from the Toyota Vehicles.

The three Toyota vehicles employed the same insulation clip shown in Figure 8. The measured insulation release temperatures in two instances were similar at 230 °C and 245 °C. However, with the Corolla, the third case using the same clip, the release temperature was measured at 141 °C. It is unclear why a lower temperature was sufficient for the insulation sample to release. A possible explanation is that suspended weight was higher which made it easier for the clip to deform.
