NHTSA-98-3588-72

## Crash Test Protocol Development for Fuel System Integrity Assessment

Paul T. Eichbrecht  
General Motors Corporation

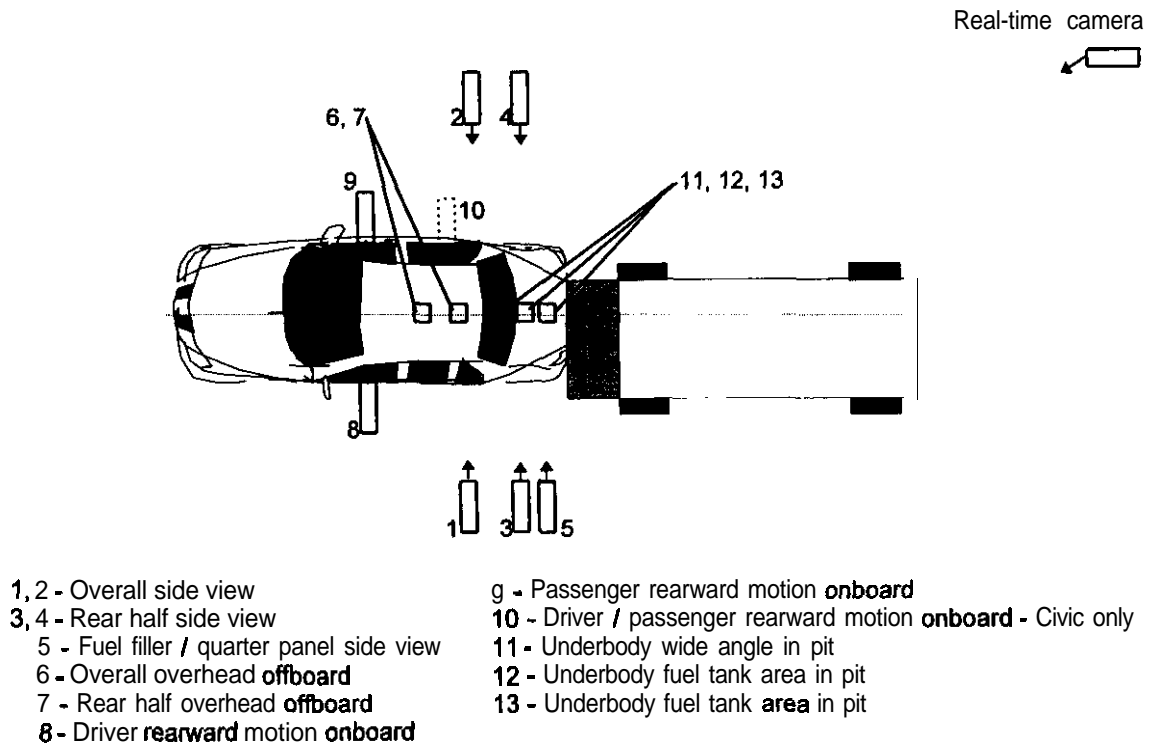
**Figure 2 - High-speed Motion Picture Camera Locations**

Real-time and high-speed motion picture cameras were used to film each test. Cameras were located as illustrated in Figure 2. Post-test conditions and the post-test static roll-over tests were documented by video camera.
