FIRE SAFETY PERFORMANCE OF MOTOR VEHICLES IN CRASHES

Kennerly H. Digges¹
R. Rhoads Stephenson¹
Paul G. Bedewi²

¹Motor Vehicle Fire Research Institute (MVFRI)
²FHWA/NHTSA National Crash Analysis Center –
The George Washington University
USA
Paper Number 422

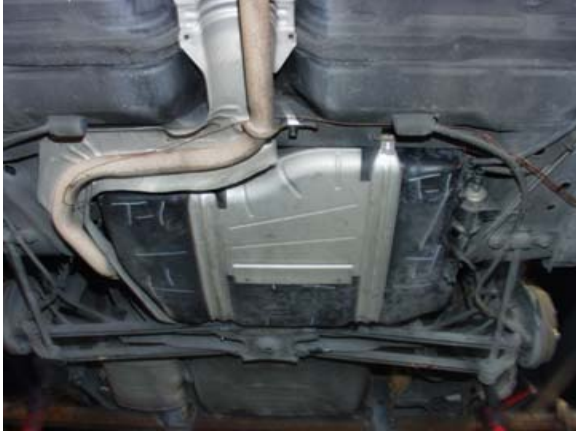
Figure 11. "Pancake" shaped tank pre-test.

Other observations made from the tests included the location and size of the initial leak that occurred before the fire was extinguished. The two pancake tanks leaked at the same place – the bottom left rear corner. In both cases, the leaks were very small. The two square tanks both leaked in locations that were associated with loading by the mounting strap. Both tanks also leaked or were severely weakened at the front right top corner due to sagging of the tank. The rate of leakage from the square tank was greater than for the pancake tank. The two long tanks both leaked due to sagging of the front part of the tank that overhung the mounting straps. The leakage occurred at the front of the tank or at the straps. The rate of leakage was greater than the square tank. The post test deformation of the “pancake” tank, the “long” tank, and the “square” tank are shown in Figures 14 through 16.

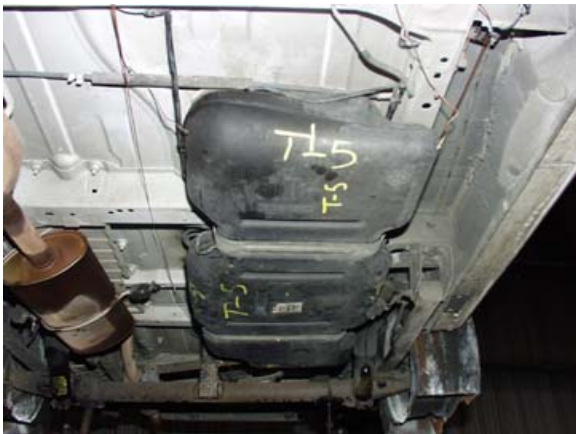
Figure 12. "Long" shaped tank pre-test.

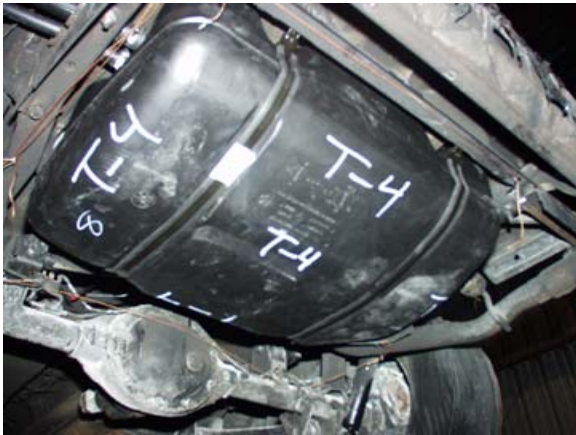
Figure 13. "Square" shaped tank pre-test.

other vehicles suffered less degradation and were not rebuilt. The second test of the “square” tank resulted in tank leakage at 101 seconds – 19 seconds short of the requirement. This difference could be explained by the increased ventilation permitted by the test buck.
