SPILLED FUEL IGNITION SOURCES AND COUNTERMEASURES

National Highway Traffic Safety Administration

DOT HS-801 722

**Contract No. DOT-HS-4-00872  
September 1975  
Final Report**

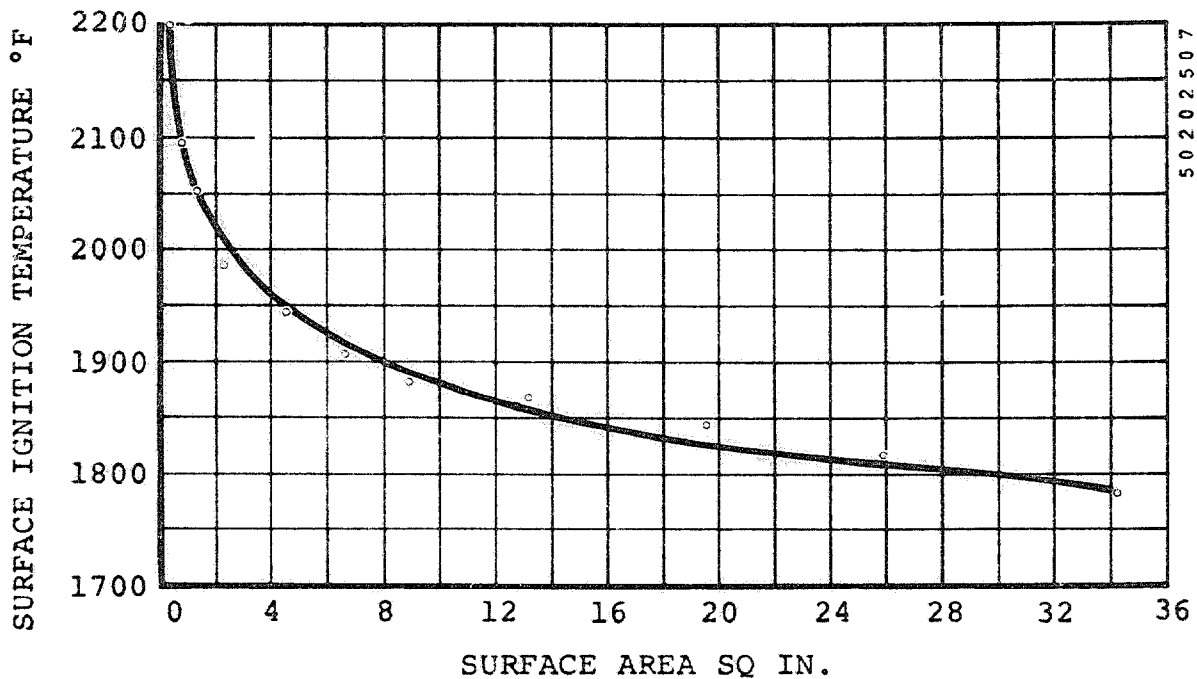
Figure 3-3. Effect of Surface Area on Surface Ignition Temperature of Quiescent 7-percent Mixture of Natural Gas and Air. Ignition Surface, Electrically Heated Nickel (Data from Reference 14).

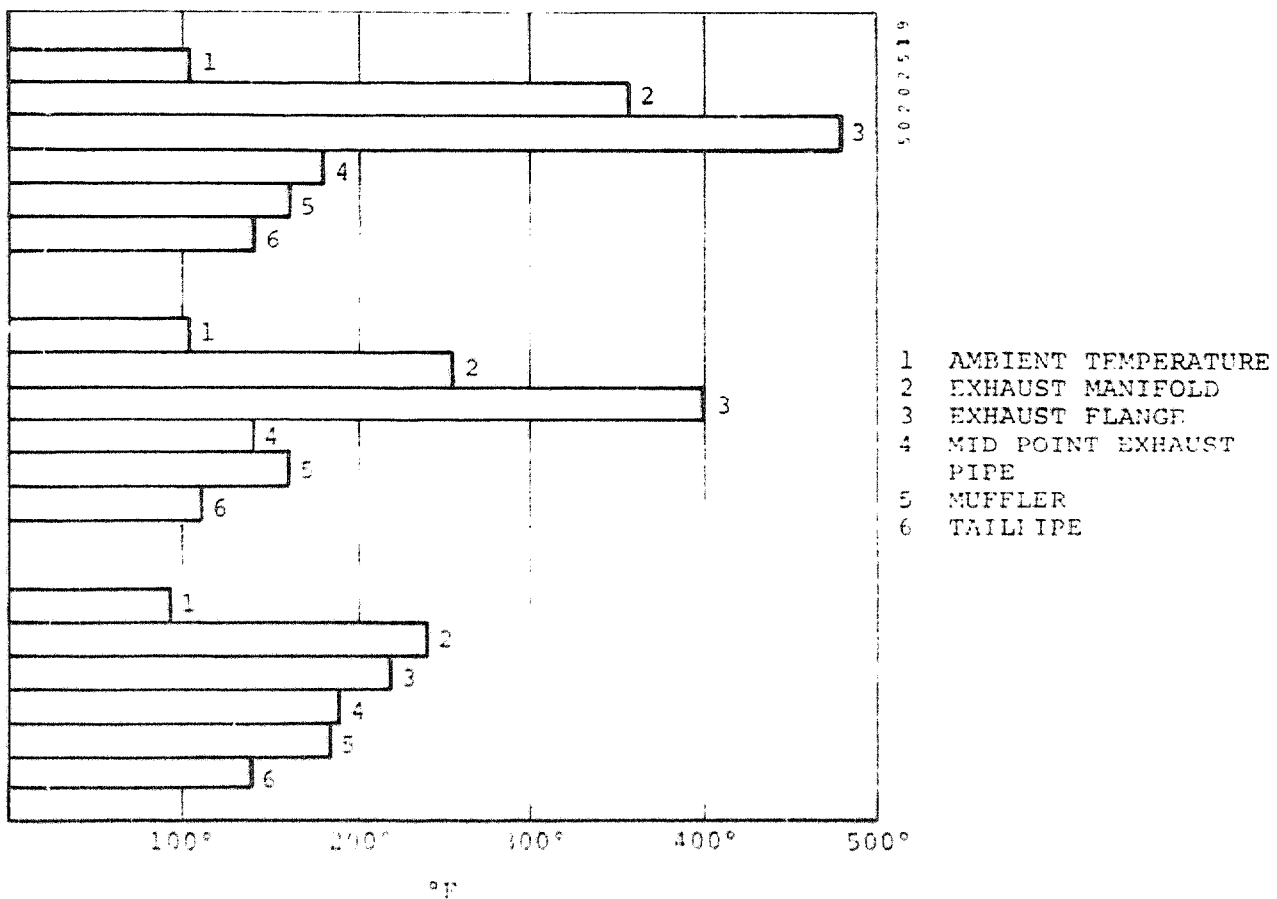
Figure 3-5. Exhaust System Temperatures - 1974 Test Vehicles.

Figure 3-5 shows the results of these tests. It is doubtful that these temperatures would lead to autoignition of gasoline. However, temperatures somewhat higher than these can be expected at higher engine output levels when the vehicle is accelerating or under load.

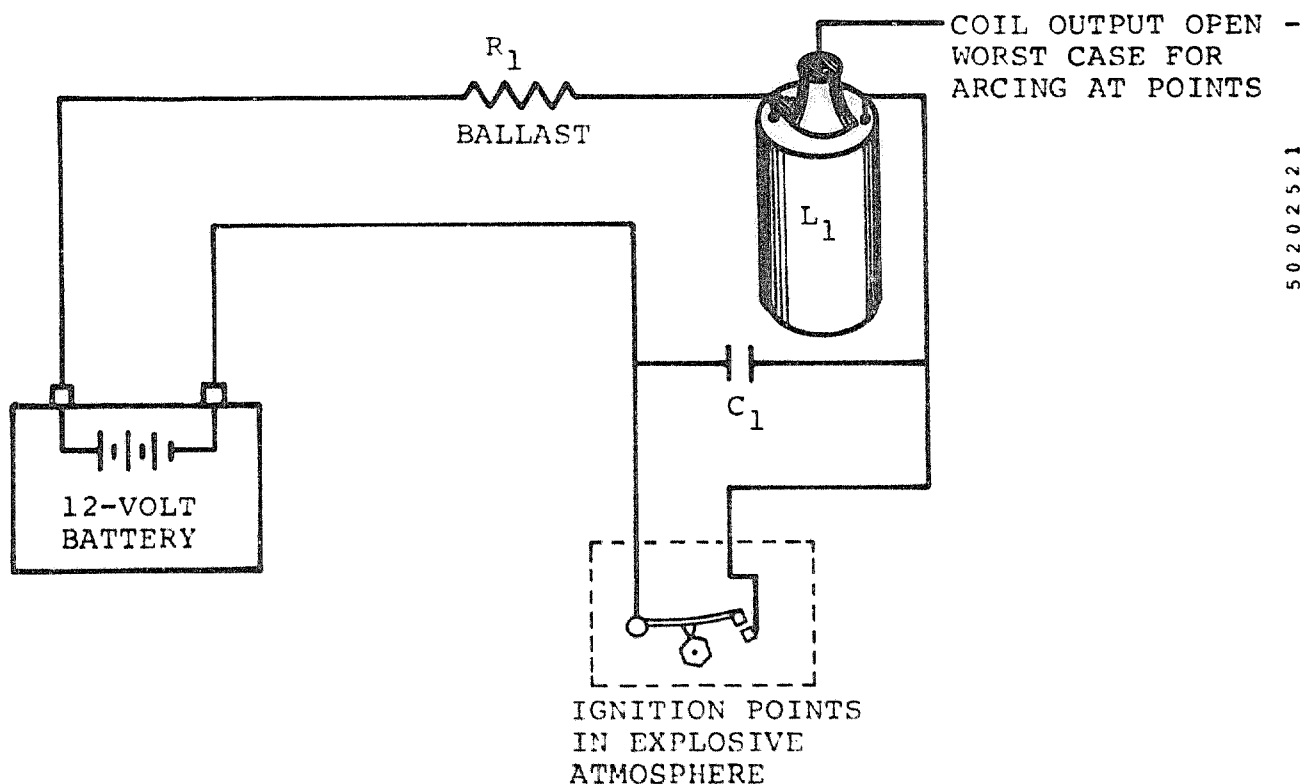
The wiring diagram for this test is presented in Figure 3-11. The breaker points were removed from a distributor and the ends cut off and soldered onto a solid 12-gage wire. These modified points were then mounted on the end of the electrode assembly over a dish of fuel. The points were set to open at a rate of 4 times per second. This particular setup with an open coil output provided the largest amount of sparking energy since all the energy of the coil was discharged across the points.

$R_1$ ,  $L_1$ ,  $C_1$ , MATCHED SET FROM TYPICAL AUTOMOBILE

Figure 3-11. Wiring Diagram for Ignition Spark From Broken Distributor.

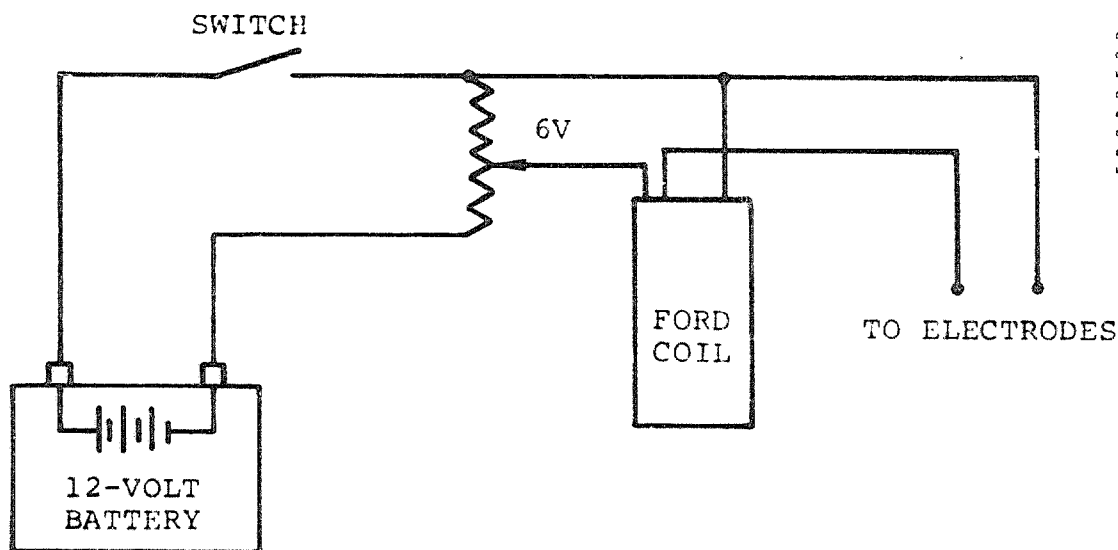
A model T Ford coil was used as the spark source for these tests. This coil has a continuous high-voltage output and uses a vibrator on the end of the coil to make and break the magnetic field at a very rapid rate. The electrode gap was maintained at 0.100 inch during these tests. The schematic in Figure 3-12 shows the Ford coil as it was installed.

Figure 3-12. Wiring Diagram for Ignition Spark From Spark Plug Wire.

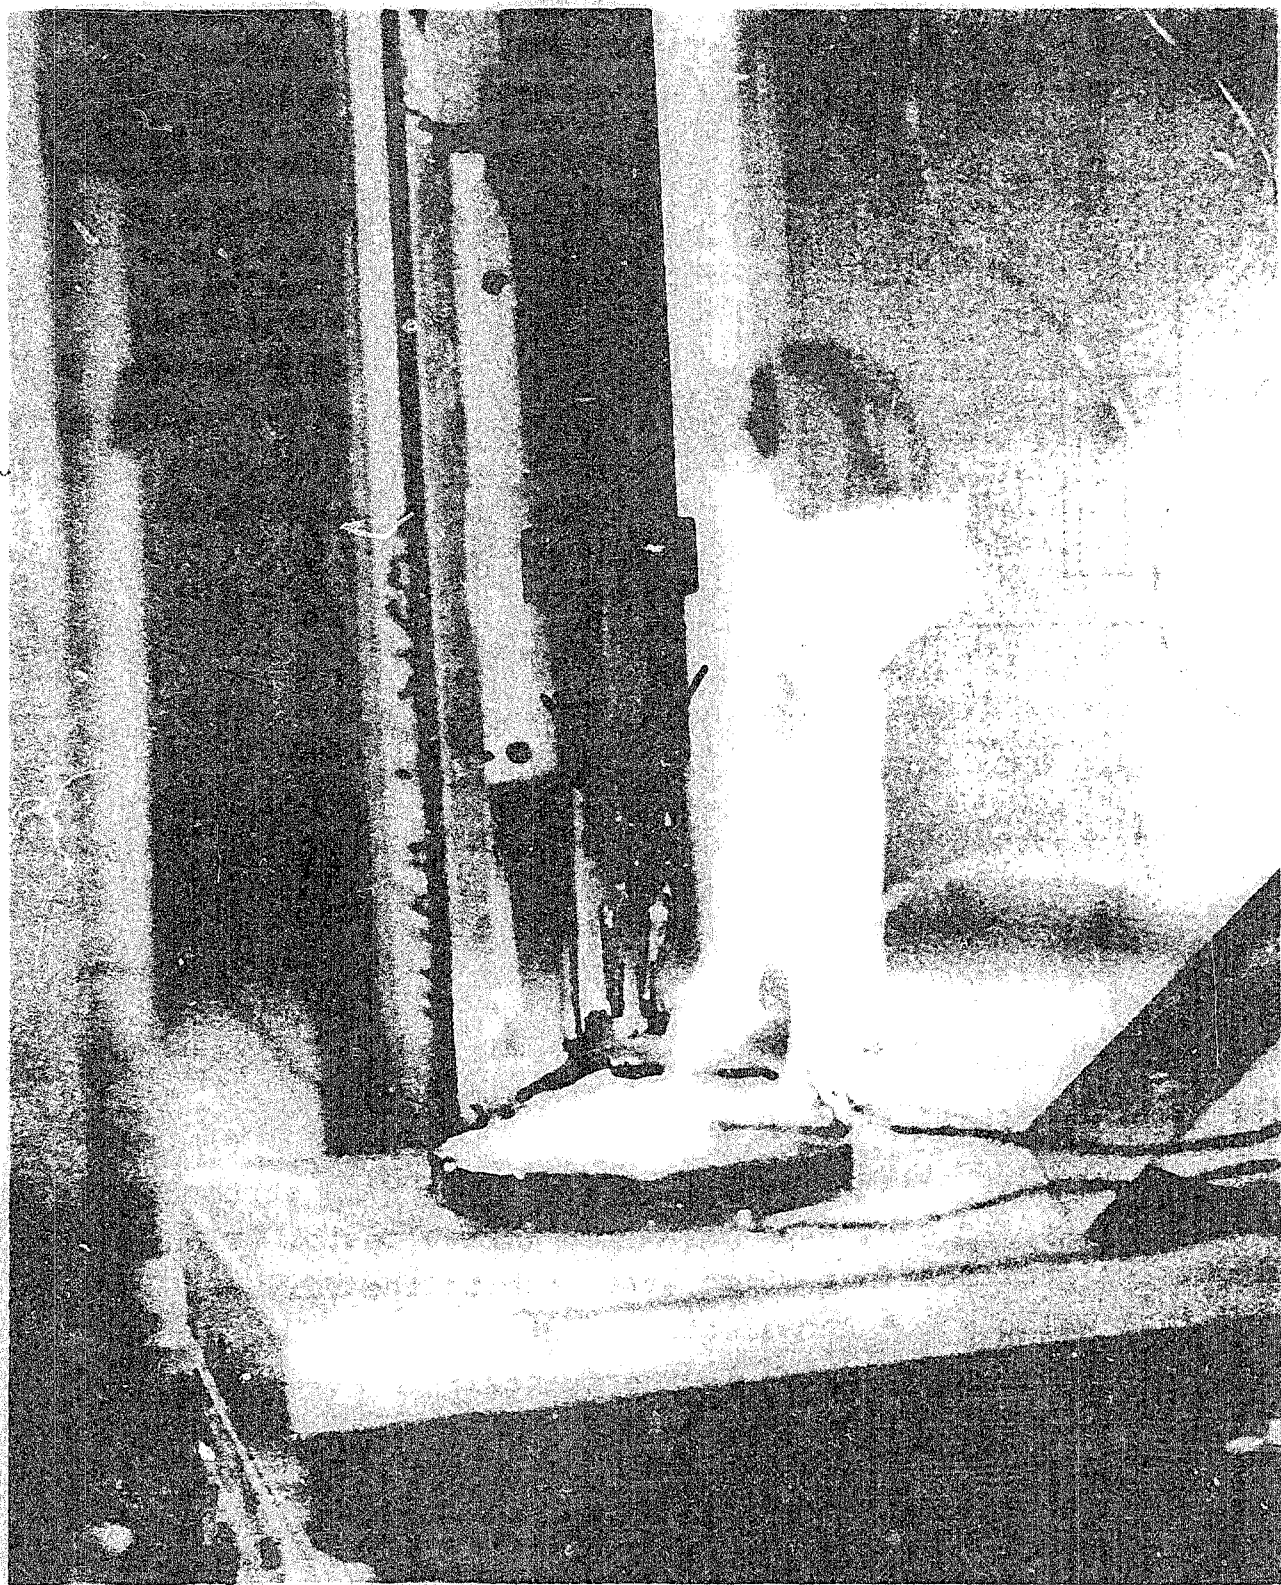
3.6.1.3.2 Broken Headlights. Figure 3-22 shows one of the tests which were run with success using broken headlights as an ignition source. Testing was done only with ambient fuel temperatures since lighted headlamp filaments generally would be exposed to a fuel spray during a rear impact in which the headlight glass of the striking car was broken. No attempt was made to determine a range for this source for the reasons discussed in the previous paragraph. The probe was set in the flammable range where ignition had occurred for the electrical sparks and the light was turned on. Ignition took place in all of the tests. Figure 3-22 shows the headlamp filament still had not broken when the fire

started. One headlamp was used for four tests which shows that the filament will last for some time when exposed to the air.

Figure 3-22. Ignition Test Using Broken Headlight as Ignition Source.

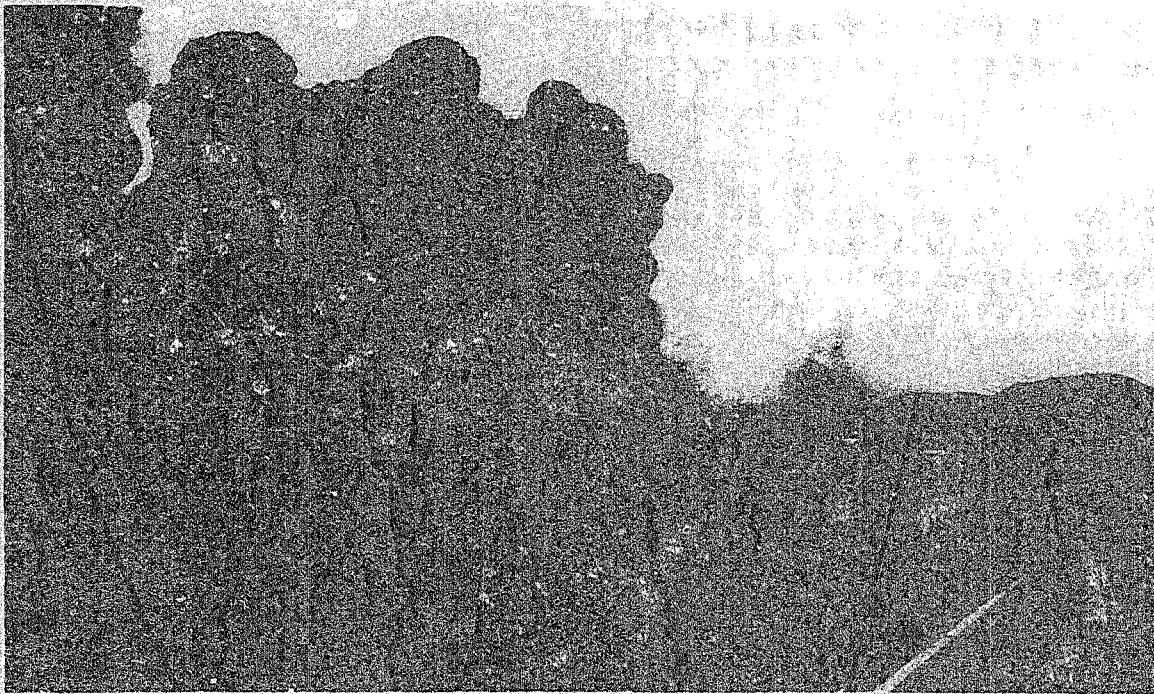
The impact velocity of the striking vehicle was 59.28 mph. Spilled fuel was evident 96 msec after impact with fire visible in 390 msec. Again the flames spread rapidly through the fuel mist and the momentum of the vehicles carried the striking car into the flames, completely engulfing it within three-quarters of a second as shown in Figure 4-8. The flaming fuel followed the vehicles from the impact point to their stopping place 120 feet beyond impact. As the vehicles stopped, the struck car was completely enveloped in flames as shown in Figure 4-9. Burning fuel stretched from the impact point to the vehicles' final resting place.

Figure 4-9. Fire When Front-to-Rear Impact Vehicles Stopped.

vehicles as there was in the struck car of the first test. This was due to the different vehicle dynamics and final resting positions of the vehicles during the two tests. In comparing Figures 4-9 and 4-15, it can be seen that the struck car in the first test came to rest in the flames while the struck vehicle in the second test came to rest at the farthest edge of the burning fuel.

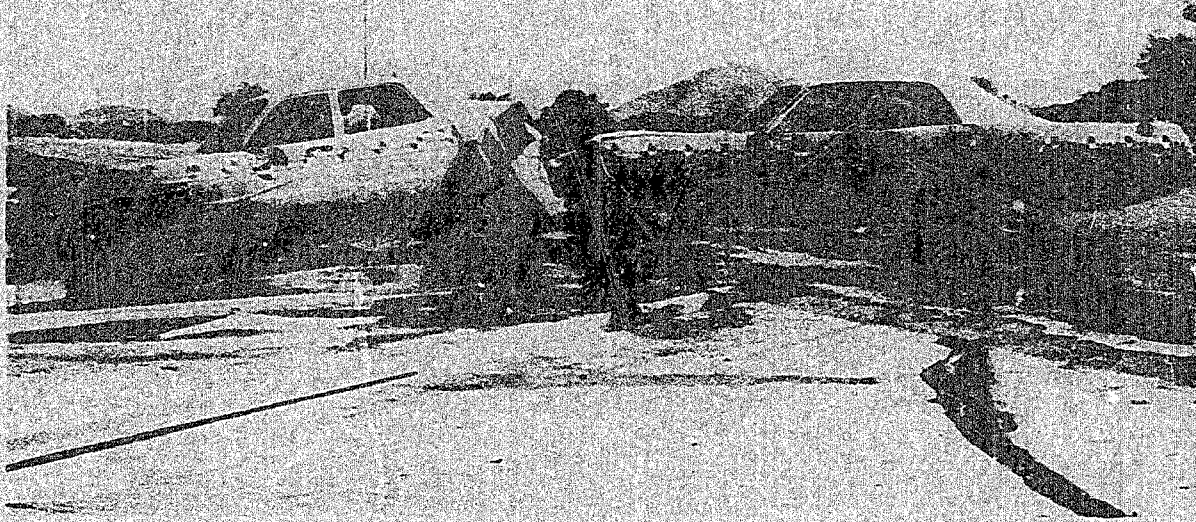
Damage to the struck car is shown in Figures 4-10 through 4-12. The total dynamic crush measured 48 inches, resulting in the rear end of the vehicle being crushed up to the rear tire. Some deformation was also visible in the kick-up area over the rear axle. The fuel tank was crushed between the rear bumper and differential and the filler spout was pulled out of the tank. However, the majority of the spilled fuel escaped from the tank through a separation of the left side seam and through a tear in the rear of the tank.

Figure 4-10. Post-test View of Vehicles,  
Front-to-Rear Test 1.

Damage to the striking vehicle was confined to the area forward of the A pillars (Figure 4-10) and was not as severe as that experienced by the barrier test vehicle due to the softness of the struck vehicle's rear structure. Electrical system damage consisted of broken headlights and severed light wires. The battery was not damaged. Although the exterior paint was scorched and blistered, there was no fire damage inside the vehicle.

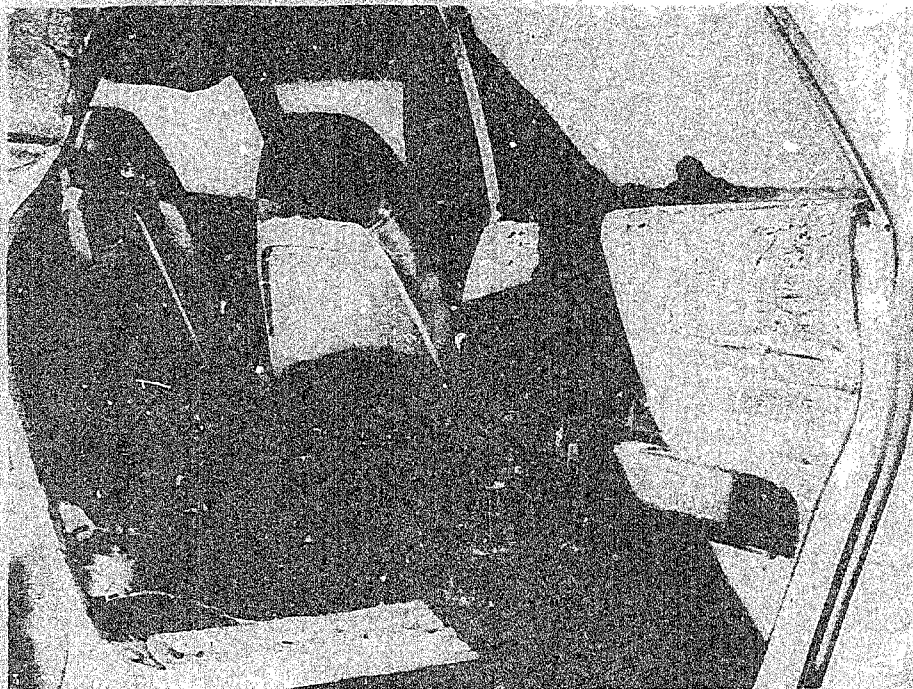
Although the fire was quickly extinguished by a foam equipped fire truck stationed alongside the impact area, there was extensive fire damage inside the struck vehicle as shown in Figure 4-13. The headlining was completely burned away and the tops of both front seats and both rear doors were scorched and blistered. The fire pattern indicated that the flames entered the vehicle through the shattered backlight and ignited the headlining.

Figure 4-13. Fire Damage Inside Struck Vehicle.

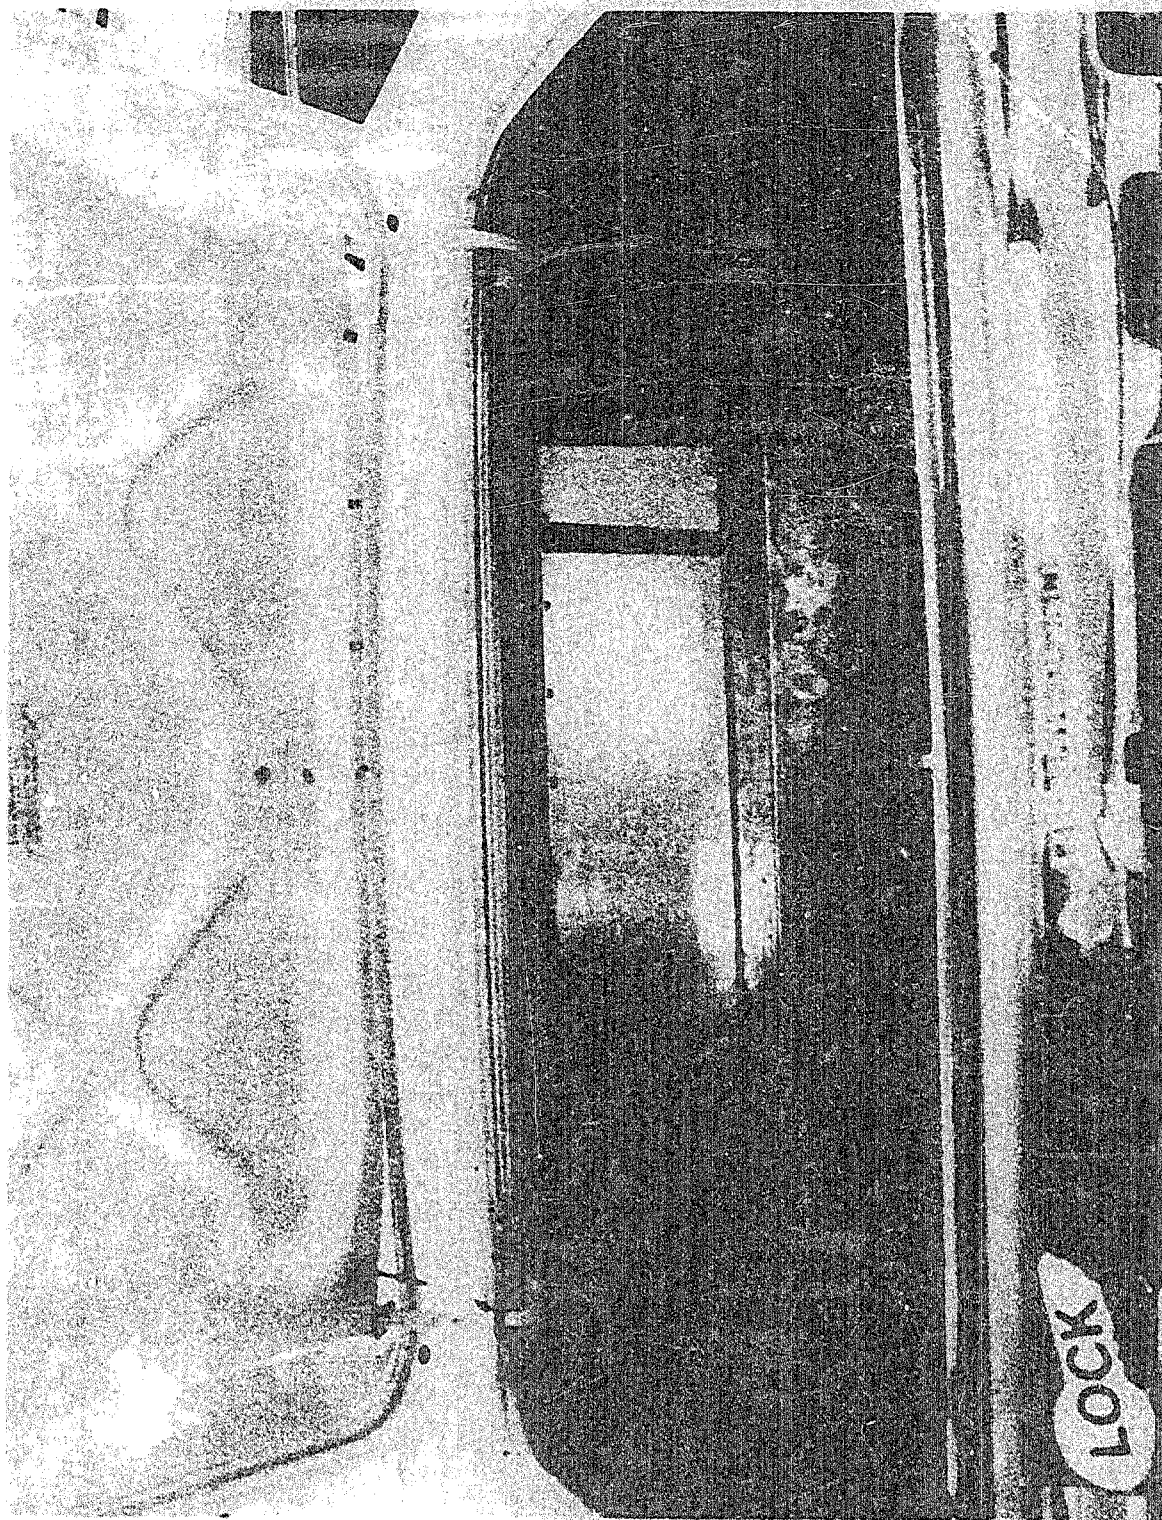
Figure 6-2. Fuel Cell and Spark Igniters for First Front-to-Rear Test.

Figures 6-2 through 6-5 show the fuel system countermeasures as installed for the demonstration tests.

The struck vehicle was modified with the relocated safety fuel tank and associated countermeasures as described in Section 6.2.1. The struck vehicle was also equipped with the spark igniter package and the fuel tank ram and bumper plates used in the baseline tests. The ram and bumper plates were in the same location as on the baseline tests so the same crush conditions were encountered even though the tank had been relocated. The igniters were relocated near the safety tank as shown in Figures 6-2 and 6-3. The safety fuel tank was filled to 90 percent of its capacity with gasoline.

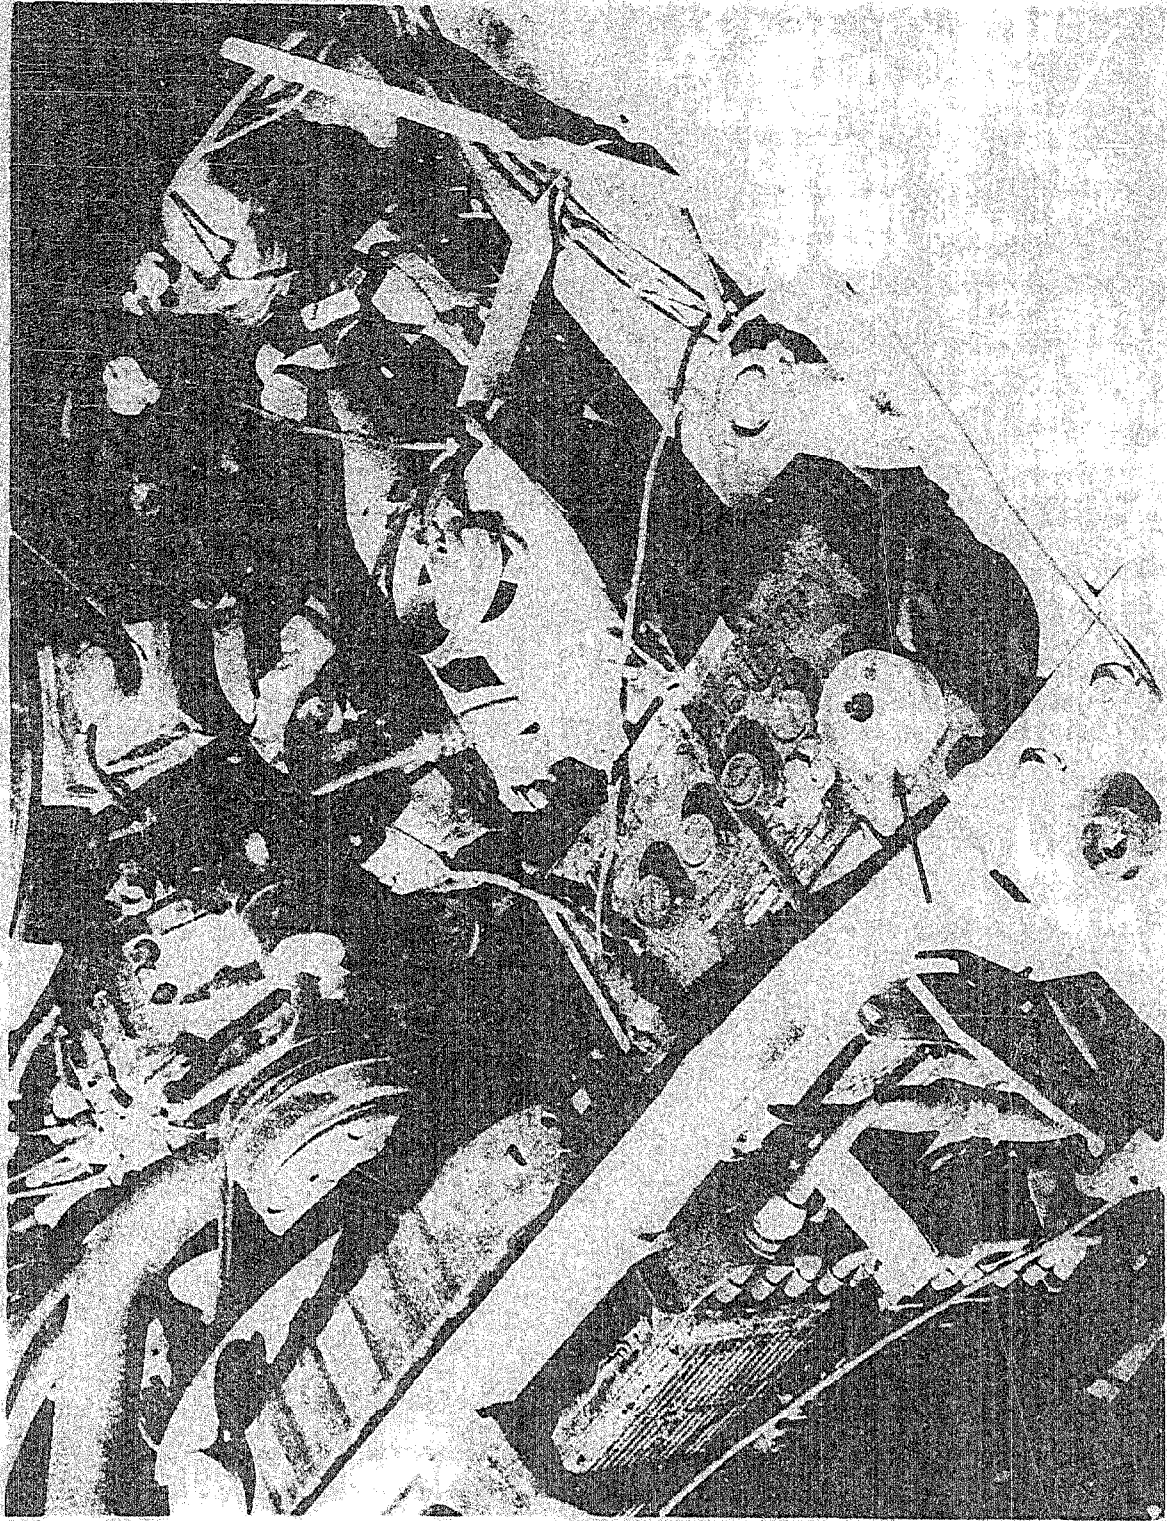
Figure 6-7. Typical Battery Terminal Shield Installation.

to prevent the engine from running after the impact. (A single switch mechanism, which was ordered from Inertia Switch, Ltd., performed both of these functions, but it was not available in time for testing.) In addition to the shutoff switches, the battery terminal was protected by a plastic/aluminum terminal protector fabricated by Ultrasystems. Figures 6-6 and 6-7 show the installation of the electrical countermeasures.

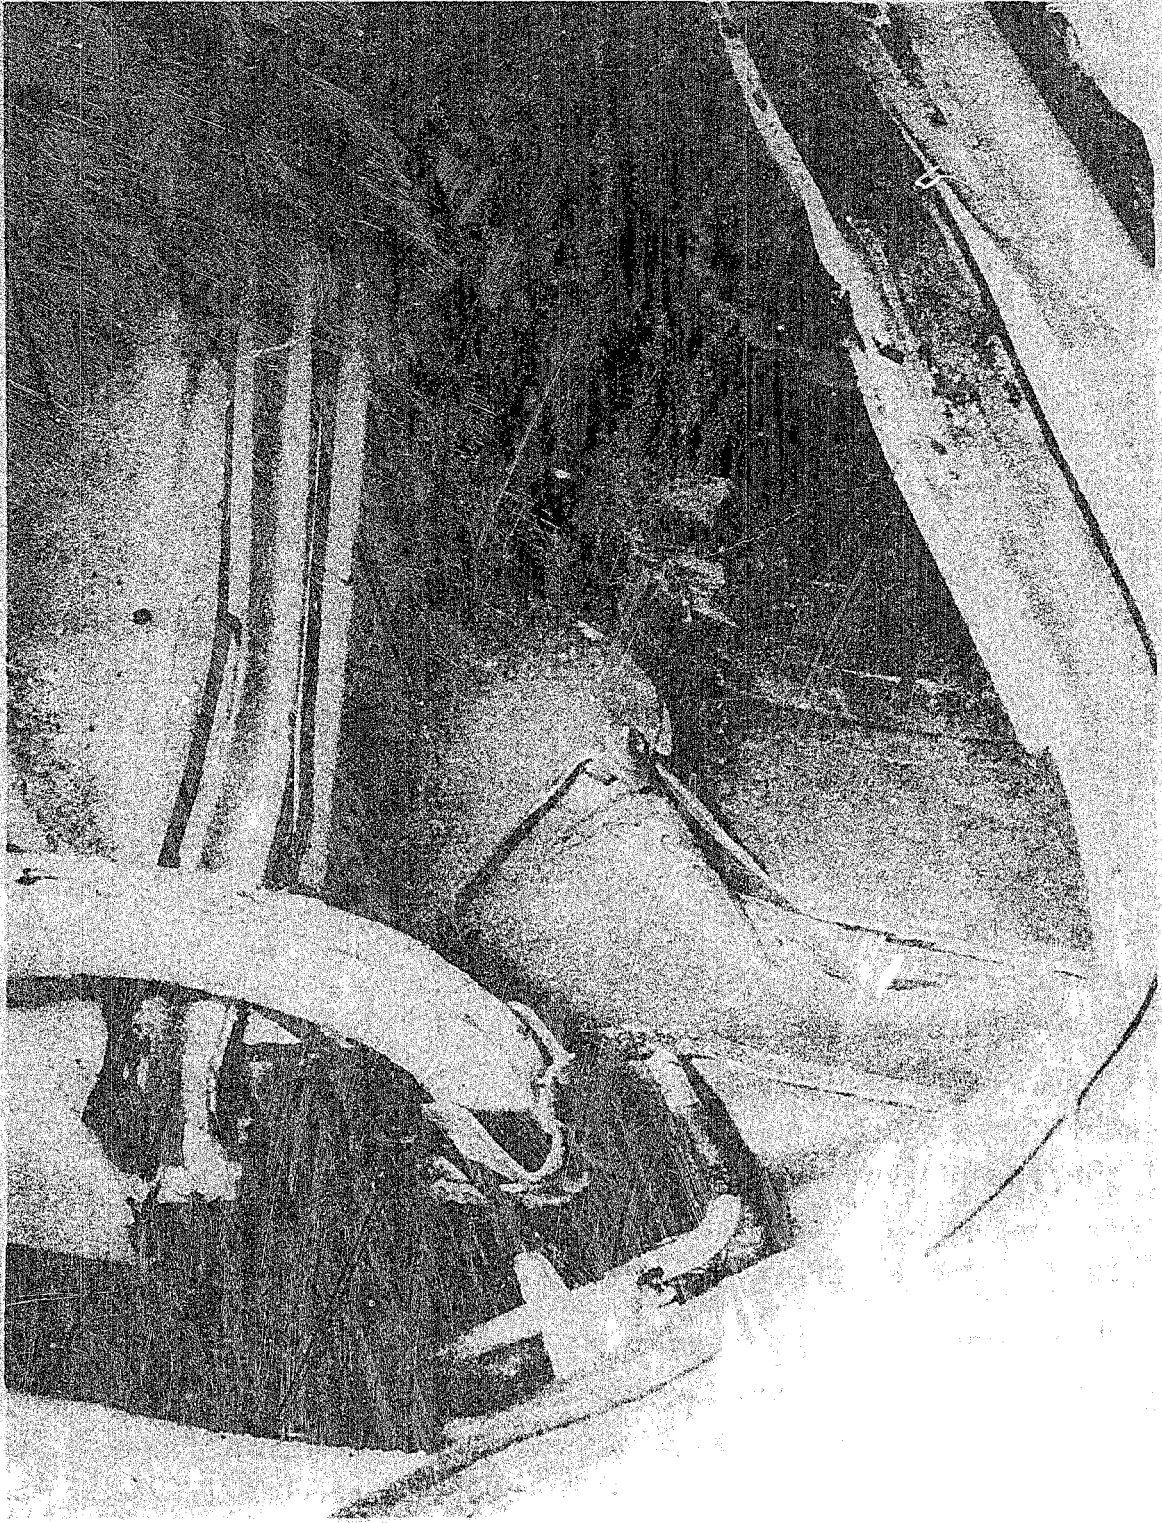
Figure 6-12. Post-test Fuel Tank Crush From First Front-to-Rear Demonstration Test.

After the safety fuel tank had been removed from the car, it was carefully inspected for leaks and was found to be in perfect condition although it had been subjected to severe impact forces. Figure 6-12 shows how the tank was crushed inward and displaced upward during the crash while Figure 6-13 shows the inward deformation of the rear firewall caused by the tank being pushed forward.

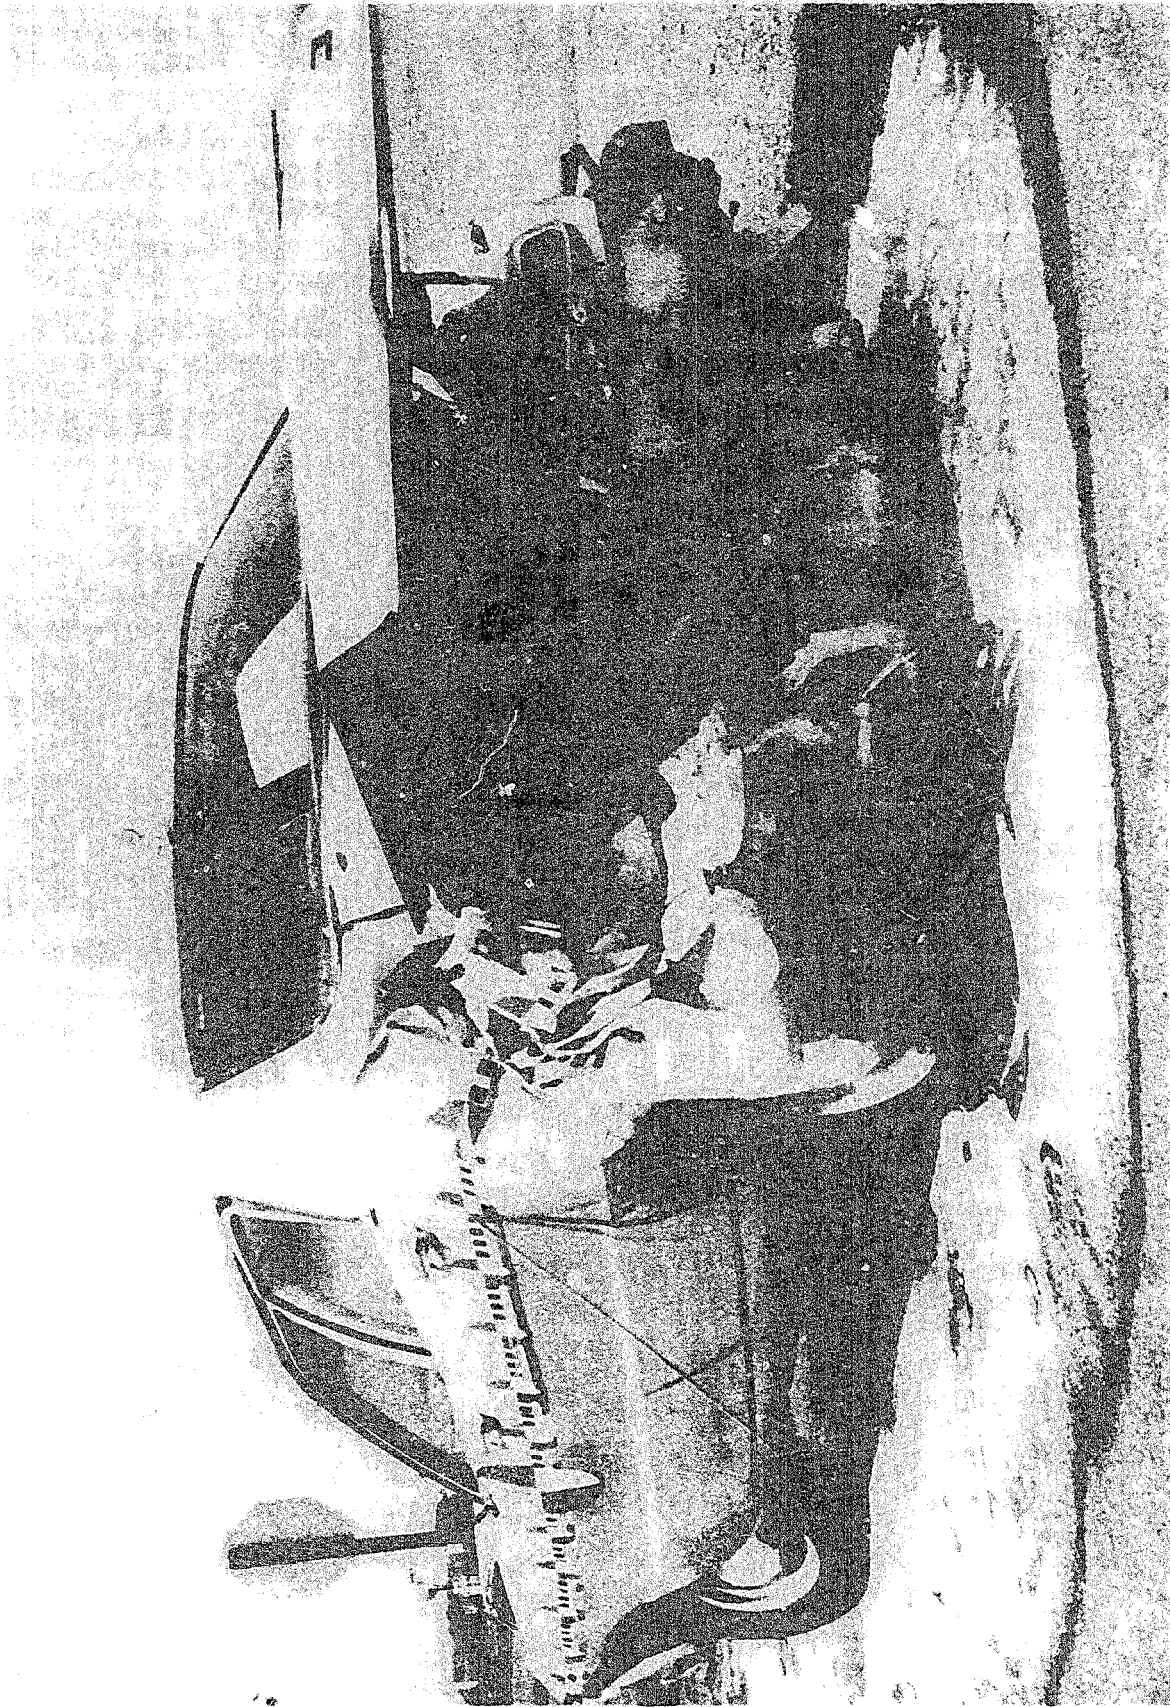
Figure 6-17. Struck Car Damage From Second Front-to-Rear Demonstration Test.

Figure 6-16 shows the damage received by the striking car while Figure 6-17 shows the damage received by the struck vehicle. The area had been washed down after the test to remove the gasoline.
