TECHNICAL REPORT

Project ID 003018009

VOLUME I

POST COLLISION MOTOR VEHICLE FIRES

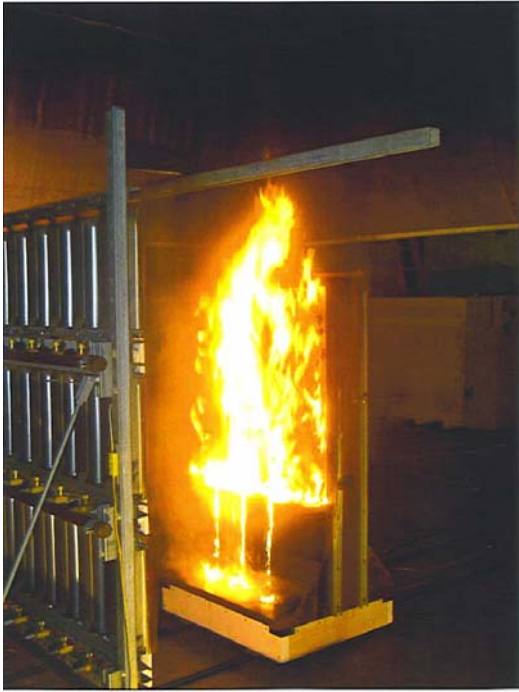
Figure 2-1 Burning of battery cover System in the ASTM E1623 ICAL. Figure is taken from Ref. 1.

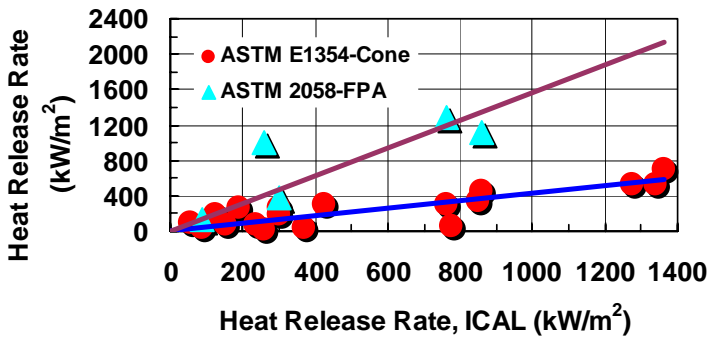
The data in Fig. 2.2 indicate that the heat release rate per unit surface area from the Cone Calorimeter is significantly lower than from the ICAL (only 42 % of ICAL). The heat release rate from the ICAL, on the other hand, is significantly lower than from the FPA (only 63% of FPA). These differences appear to be due to the melting behavior of the plastic

Figure 2.2 Correlation between the heat release rates from the ASTM E1623 ICAL for burning of part systems and from the ASTM E1354 Cone Calorimeter and the ASTM E2058 FPA for burning of samples part systems under similar heat flux conditions.

Data quantified in the ASTM E1623 ICAL are listed in Table 2-1. Correlations between the heat release rates determined in the ASTM E1623 ICAL for the vehicle part systems and in the ASTM E1354 Cone Calorimeter and the ASTM E2058 Fire Propagation Apparatus (FPA) for the vehicle sample part systems, under similar heat flux exposure conditions, are shown in Fig. 2-2.

part systems, as was noted for the differences in the heat release rates from the Cone and FPA (discussed in Volume III, Chapter I). The difference in the heat release rate for the melting type plastics in a horizontal configuration in both the Cone and FPA, is probably due to dripping and melting away of the plastic from the sample dish or the non-uniformity of the heat flux exposure (between the surface layer and bottom layer of the sample) in the Cone.

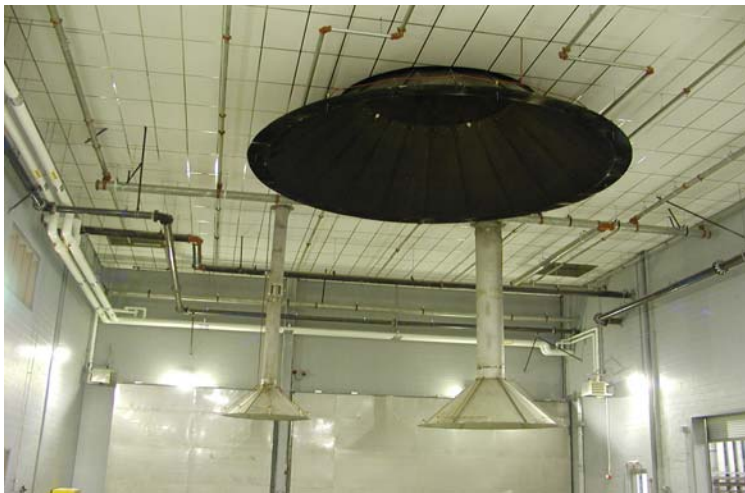
Tests were performed by FM Global in the Fire Products Collector, shown in Fig. 2-4 (right side in the back) [5,6]. The FPC has a fire products collection funnel 6.1-m in diameter, a 0.9-m diameter orifice plate, and a vertical stainless steel sampling duct with a diameter of 1.5 m. The sampling duct is connected to the air pollution control system of the Burn Laboratory at the Research Campus of FM Global. The blower of the air pollution control system induces the airflow through the sampling duct. Air enters the sampling duct via the orifice plate.

Figure 2-4 The Fire Products Collectors at FM Global. Collector in the back right side was used in the tests. Details are described in Ref. 5.

The heat and products generated during the test are captured in the sampling duct of the FPC, where measurements are made for the temperature, linear velocity, optical transmission, and chemical composition of the product-air mixture about six duct diameters from the orifice plate. These measurements are used to calculate the heat release rate and generation rates of fire products including

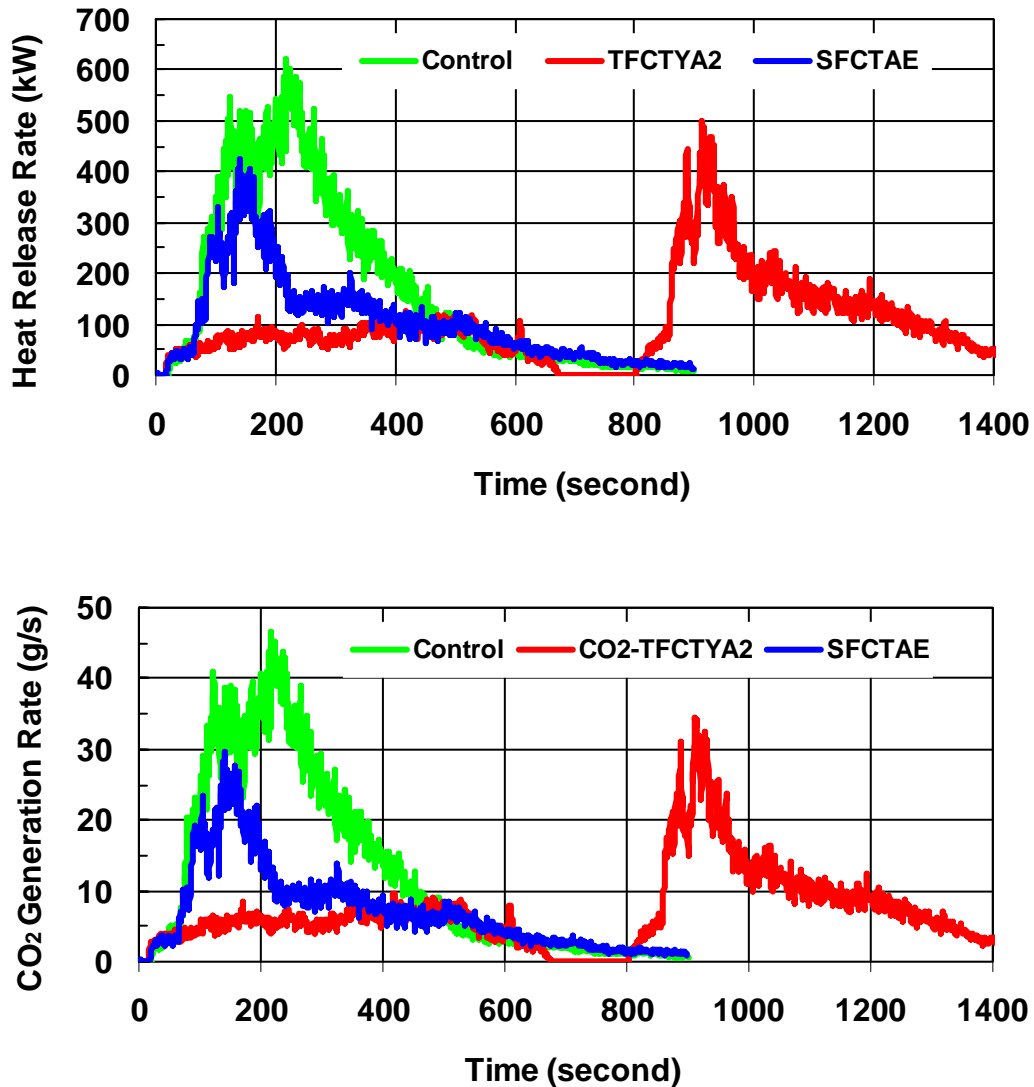
Figure 2-5 Heat release rate and generation rate of CO₂ in the burning of non-fire retarded (control) and fire retarded (TFCTYA2 and SFCTAE) HVAC units for a 1999 Honda in the Fire Products Collector.

Each HVAC unit was 9 kg in weight and was about 1.5-ft (0.46-m) wide and 3.5-ft (1.1-m) long. Each unit was ignited by 1450-ml of heptane contained in a 9 square inch (230-mm square) and 1-in (45-mm) deep pan, that burned for about 11 minutes with a heat release rate of 80-kW. In the tests, heat release rate and generation rates of CO, CO₂, hydrocarbons, and smoke were measured. From the load cell data, mass loss rate was derived. The data from these tests are plotted in Figs. 2-5 and 2-6.

Data in Figs. 2-5 and 2-6 show that:

The fire-retardant treatments of the HVAC units appear to be effective in reducing the fire growth; however, the peak burning intensity is reduced only slightly and thus in a crash fire, it will not be able to resist the penetration of flame into the passenger compartment.

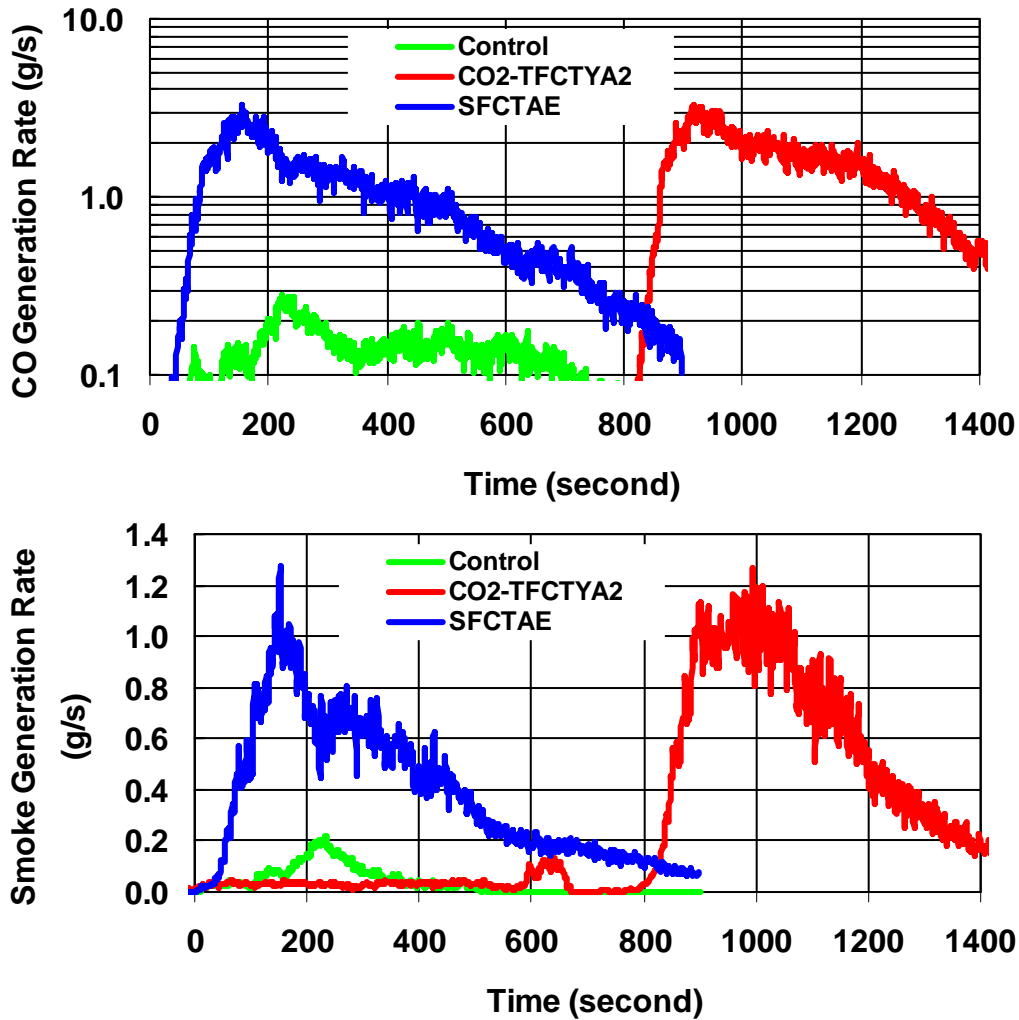
Figure 2-6 Generation rates of CO and smoke in the burning of a non-fire retarded (control) and a fire retarded (TFCTYA2 and SFCTAE) HVAC unit for a 1999 Honda in the Fire Products Collector.

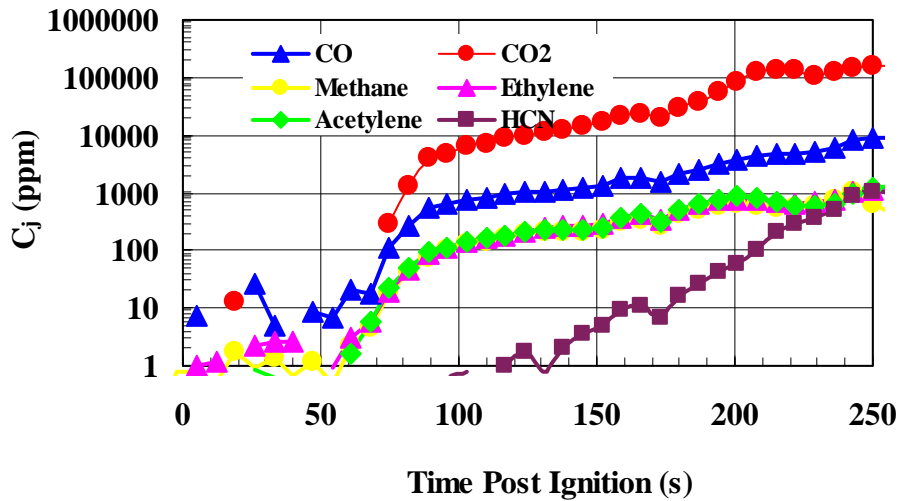
The concentrations of products in the passenger compartment were measured at a single location between the driver and passenger seats, slightly over the top of the seats. Figure 3-3 shows an example of the measured data for test #2. There is rapid increase in the concentrations of products paralleling the fire growth as flames enter the passenger compartment (80 to 120 s and ignition of one of the seats). Formation of HCN starts at about 120 s and its concentration increases with time, supporting the observation of ignition and burning of polyurethane based seat. A similar behavior is observed for the CO and CO₂ concentration profiles in the fire plume, as shown in Fig. 3-4 for test #2.

Figure 3-3. Concentrations of products in the passenger compartment versus post ignition time for test #2.

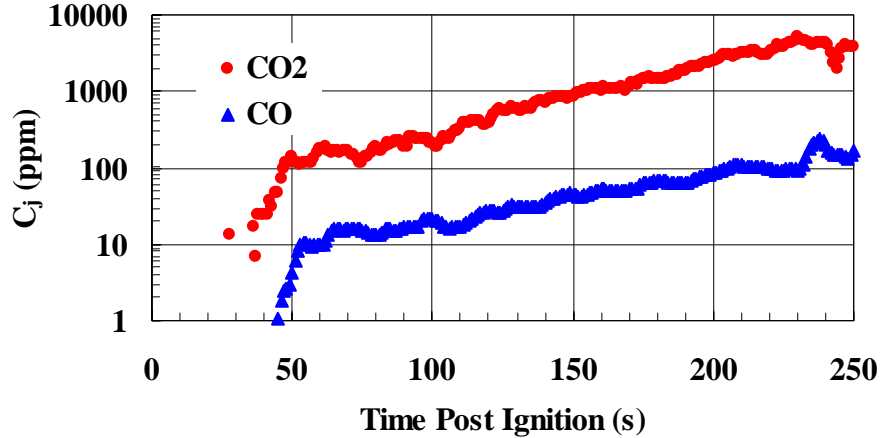
Figure 3-4. Concentrations of CO and CO₂ in the fire plume versus post ignition time for test #2.

The increase in the concentrations of products in the passenger compartment creates untenable conditions leading to flashover and the increase in the concentration of products in the fire plume results in the increase in the fire intensity of the burning vehicle.

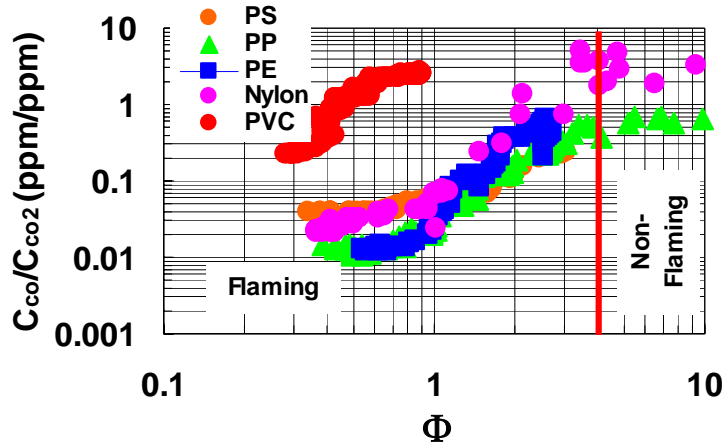
The ratio is commonly used to examine the combustion behavior of plastics and liquids. An example is shown in Fig. 3-5, where the ratio of CO to CO₂ concentration (C_{CO}/C_{CO_2}) is plotted against the equivalence ratio, Φ . For $\Phi < 1$ (fuel-lean conditions), the C_{CO}/C_{CO_2} ratio is highest for PVC (halogenated fuel), followed by PS (aromatic fuel) and nylon, PE, and PP (aliphatic fuel) in that order. For fuel-rich conditions, the ratio for aliphatic fuels becomes higher than for the aromatic fuel (highest for nylon comparable to PVC).

Figure 3-5. CO and CO₂ concentration ratio versus the equivalence ratio in the combustion of various plastics. Data are taken from Ref. 17.

The C_{CO}/C_{CO_2} ratios in Tables 3-13 and 3-14, just before $t_{u,f}$, are also similar to the ratios that are closer to the stoichiometric combustion conditions for aliphatic fuels in Fig. 3-5. Under these conditions, gas temperatures are higher and thus there is a higher possibility of burn injuries to passengers relative to the injuries due to toxicity and lethality, a conclusion similar to that derived from the estimations for times to pain, 2nd and 3rd degree burns, flashover, toxicity, and lethality in Chapter V.

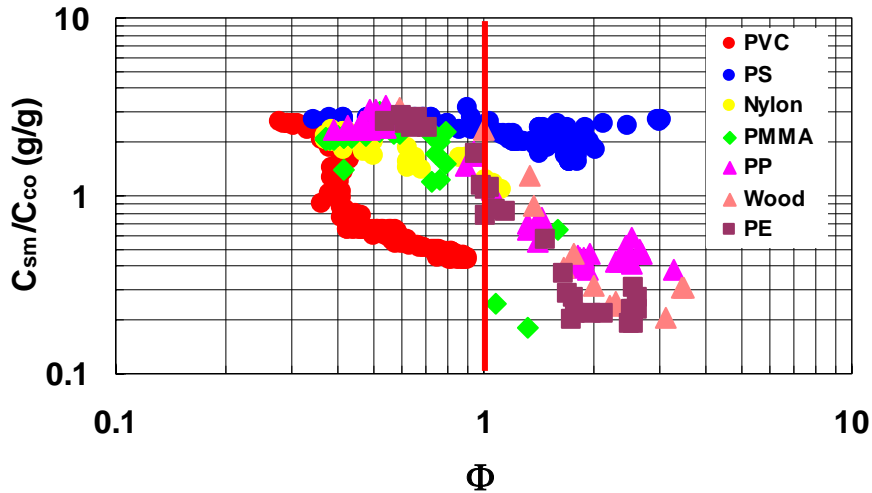
Examples of the data for the concentration ratios of smoke to CO are shown in Fig. 3-6, where data are taken from Ref. 16. The concentration ratios of HCN and CO along with the CO to CO₂ ratios are listed in Table 3-15, where data are taken from Ref. 18. A chemical kinetic model for the formation of CO, CO₂, and HCN from a mixture of methylamine and ethylene, following a stationary flamelet concept, was used to calculate their concentrations [18]. The experimental concentration ratios in Table 3-15, were measured in the combustion of nylon-6,6 in the ISO 9705 room with 0.89-m and 0.56-m high openings [18].

Figure 3-6. Smoke to CO concentration ratio versus the equivalence ratio for the combustion of various plastics. Data are taken from Ref. 17.

An examination of the data in Fig. 3-6 shows that for the fuel-lean conditions, the C_{sm}/C_{CO} ratio is about 3 g/g for all the fuels included in the figure. For PS, an aromatic fuel, the ratio remains approximately constant (between about 2 and 3 g/g) in the fuel-lean as well as fuel-rich combustion conditions. For PVC, a halogenated fuel and other aliphatic fuels, the C_{sm}/C_{CO} ratio decreases as combustion conditions change from fuel-lean to fuel-rich. These results suggest that since soot in smoke has an aromatic structure, conversion of aromatic fuel pyrolyzate to soot

For the vehicle burn tests, the C_{sm}/C_{CO} ratios in the passenger compartment and in the plume in Tables 3-13 and 3-14 (just before t_{u,n}) are similar to values in Fig. 3-6 that are closer to the stoichiometric combustion for aliphatic fuels.

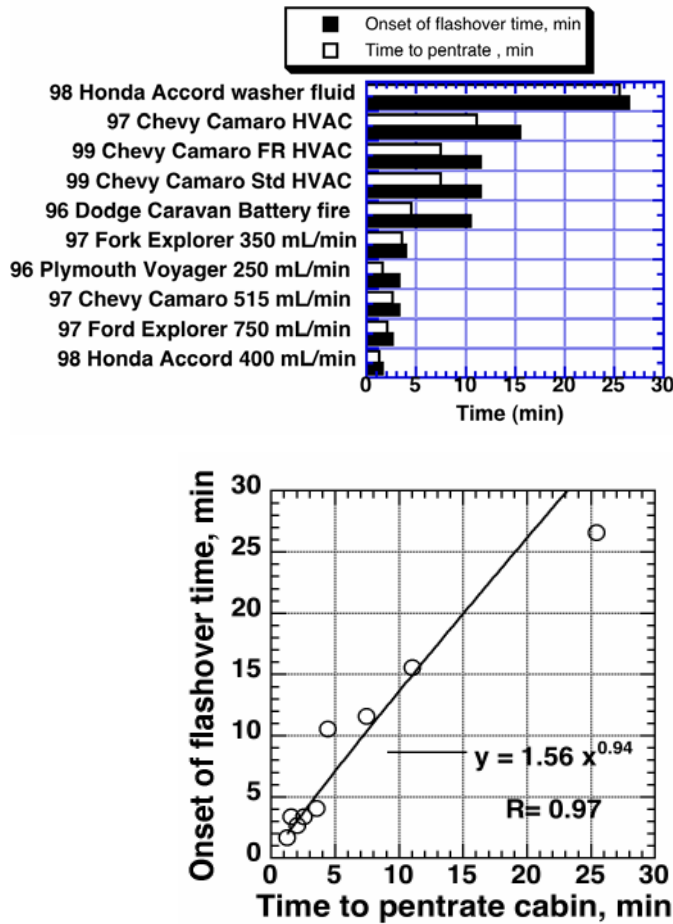
Figure 4-2 indicates the time for the fire to penetrate either the windshield or the undercarriage and the corresponding time to flashover. These times are well correlated as directly shown in Fig. 4-2. Indeed, there is nearly a linear relationship between the times with a coefficient of proportionality of about 1.5. The difference in the times is 2.3 minutes with a

Figure 4-2. Penetration and flashover times

standard deviation of 2.1. Hence, flashover is likely to occur within several minutes following fire penetration into the passenger compartment. The nature of the fire penetration can be pieces of flaming windshield screen falling on the seats and dash panel, flames impinging on the headliner, or flames entering in the seat cushions. Flames and hot gases entering through the HVAC vents is also important. Thus, for flame penetration into the passenger compartment, HVAC system and extent of the breaking of the windshield are important.

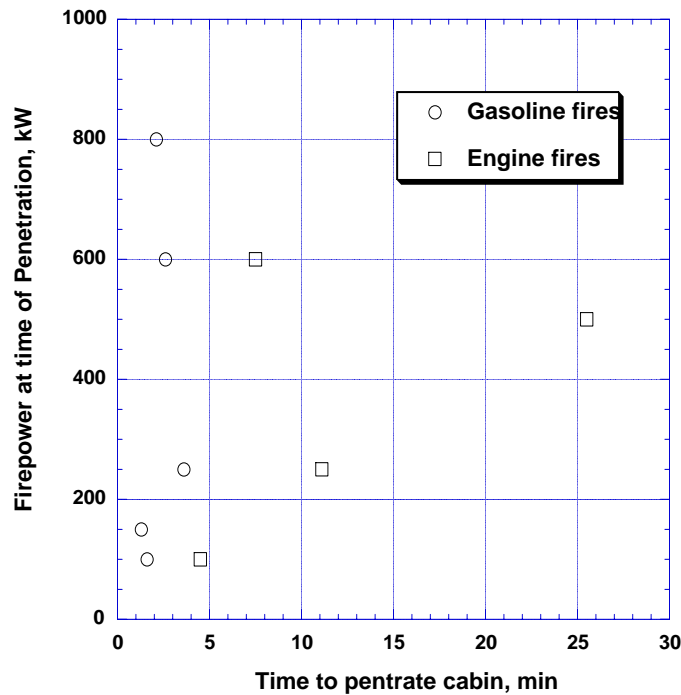
Figure 4-3 shows the firepower at the time of flame penetration and the time for flame penetration following gasoline or engine ignition scenarios. The time for flame to penetrate the passenger compartment is not a function of the gasoline firepower or leak rate, as this depends on the under carriage openings exposed. The time for flame to penetrate the windshield is somewhat dependent on the firepower of that fire, but depends mostly on when the engine fire significantly affects the windshield.

Figure 4-3. Firepower and time at flame penetration into the passenger compartment

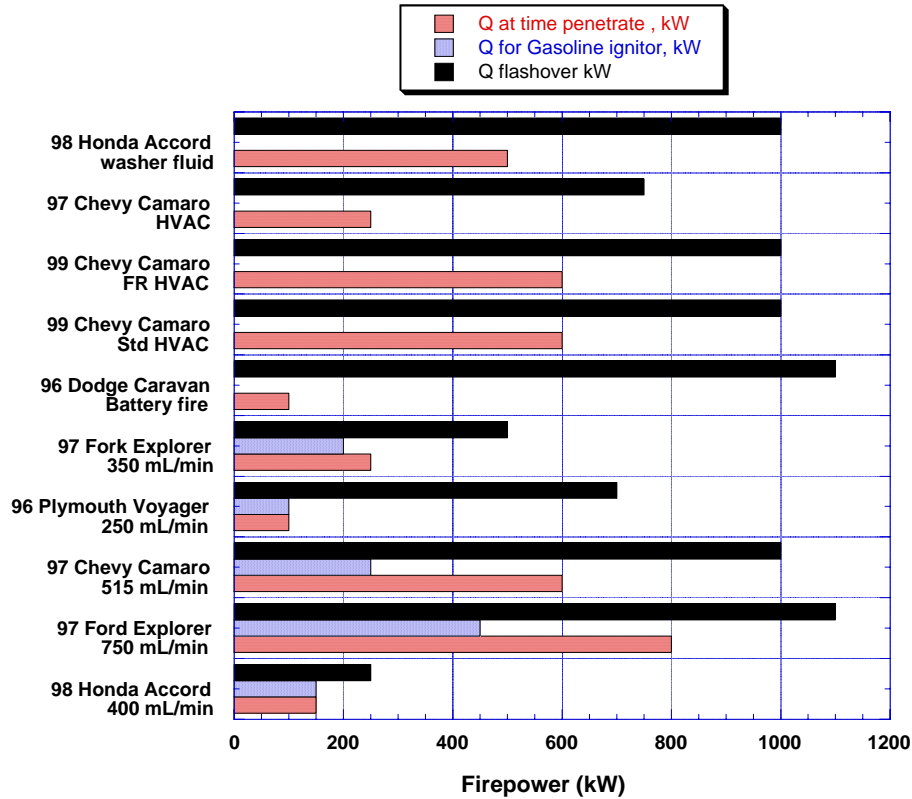
Figure 4-4 indicates the firepower at the time of flame penetration into the passenger compartment and at the onset of flashover. The components of this fire can include the gasoline leak, the engine components and exterior components ignited. In the case of the gasoline-initiated fires, it can be seen that the firepower of the gasoline was nearly the same as the

Figure 4-4. Firepower at flame penetration and flashover

firepower at the time of flame penetration noted into the passenger compartment, except in one test. That test was the 1997 Ford Explorer (test #5, NHTSA 3588-188) that had the highest leak rate and gasoline firepower, and the rear tire ignited and burned after 30 seconds following ignition. Thus, the

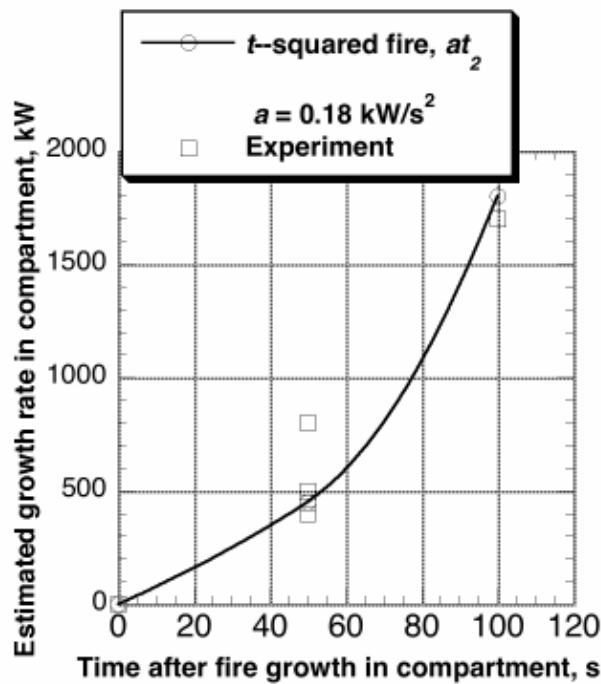
An attempt was made to exclude the effect of the external gasoline pool and additional burning from the vehicle exterior from this fire growth. The latter was difficult and done by noting the time for flame penetration and forcing the firepower to zero at that time. This gave a very rough t-squared growth that characterized the passenger compartment fire with a coefficient of 0.18 kW/s². This is shown in Figure 4-7. Although it is a crude estimate, it is reasonably indicative of the rapid fire growth in the passenger compartment once flames enter from the bottom.

Figure 4-7. Estimated growth rate of the passenger compartment fire.

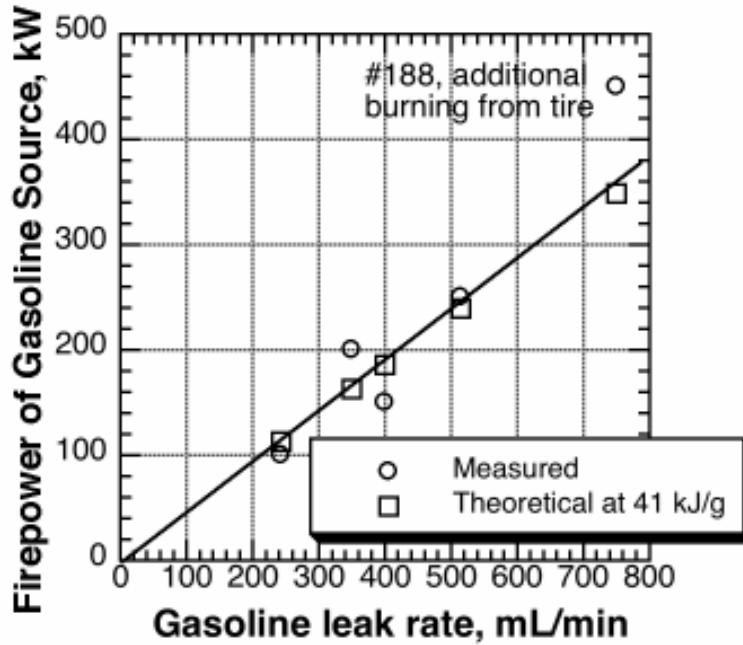
Figure 4-8. Gasoline firepower based on leak flow rate and calorimeter

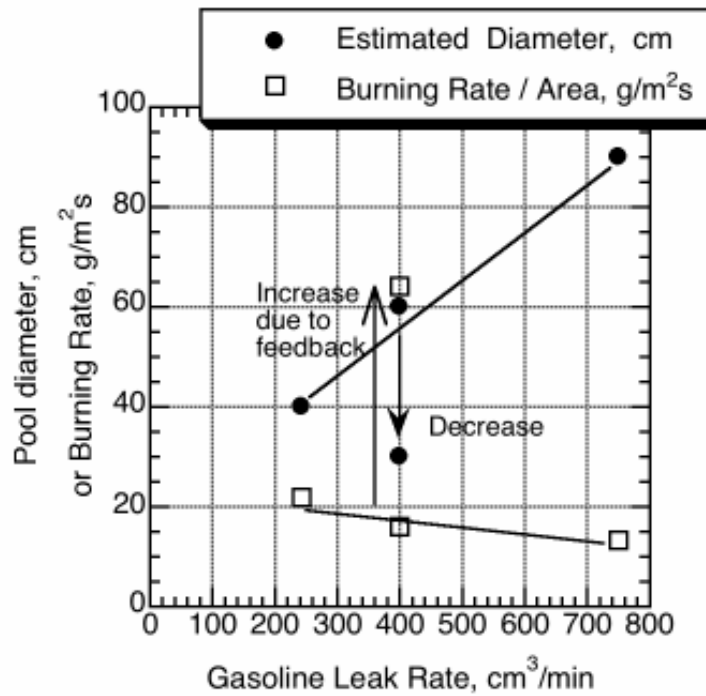
Figure 4-9. Burning flux and diameter of gasoline fires

where \dot{m}'' is the burning rate per unit area (mass flux). Estimated pool diameters are indicated in Figure 4-9. They appear to have not exceeded 1 m in the GM tests. The mass flux depends on the heat transfer available to evaporate the gasoline. In these fires under the vehicle, the heat radiated from the heated undercarriage will affect the flux. This was obvious in the Honda test #8(NHTSA 3588-#201), where the pool area decreased as the burning rate increased. This increase was suggested due to radiation feedback. The burning flux appeared to increase from about 18 to 65 g/m²-s. Generally, the data suggested a burning flux of roughly 20 g/m²-s.

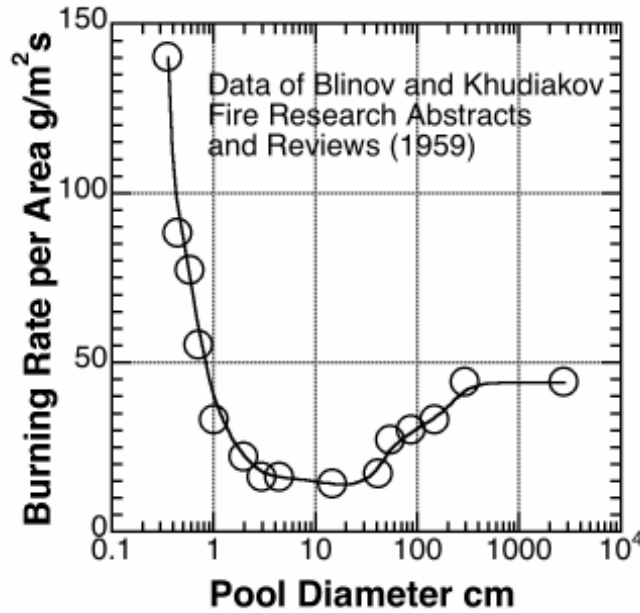
Figure 4-10. Burning rate for free burning gasoline pools [3]

A classical study by Blinov and Khudiakov [3] gives the mass flux free burning gasoline pools, which is shown in Figure 4-10. It can be seen that the asymptotic flux is about $45 \text{ g/m}^2\text{-s}$, but has been reported as high as $55 \text{ g/m}^2\text{-s}$ in the literature. These results along with the equation for mass leak rate can yield the fire diameter. The diameter of the fire is important in auto fires since it will indicate the range of exposure. *Moreover, the breach of a tank in a crash and the subsequent leak rate is an important parameter missing from the current study.*

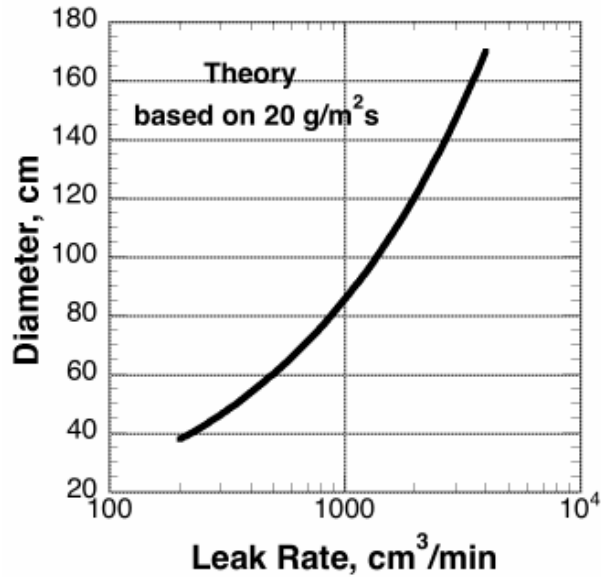
Figure 4-11. Theoretical estimates of gasoline pool diameter.

Figure 4-11 gives a theoretical estimate for the pool diameter assuming a burning flux of $20 \text{ g/m}^2\text{-s}$ as suggested by these fires. It would appear that diameters of about 150 cm, at most, might be expected for about $4000 \text{ cm}^3\text{/min}$ —a much larger leak rate than was used in these studies. However, in a crash scenario larger leakage rates might occur from massive tank ruptures, and information on these rates are not considered. Moreover, the effects of acceleration of the air born liquid and its dispersal into droplets from a ruptured tank in a crash, can produce other fire effects than have been observed in the tests reviewed here.

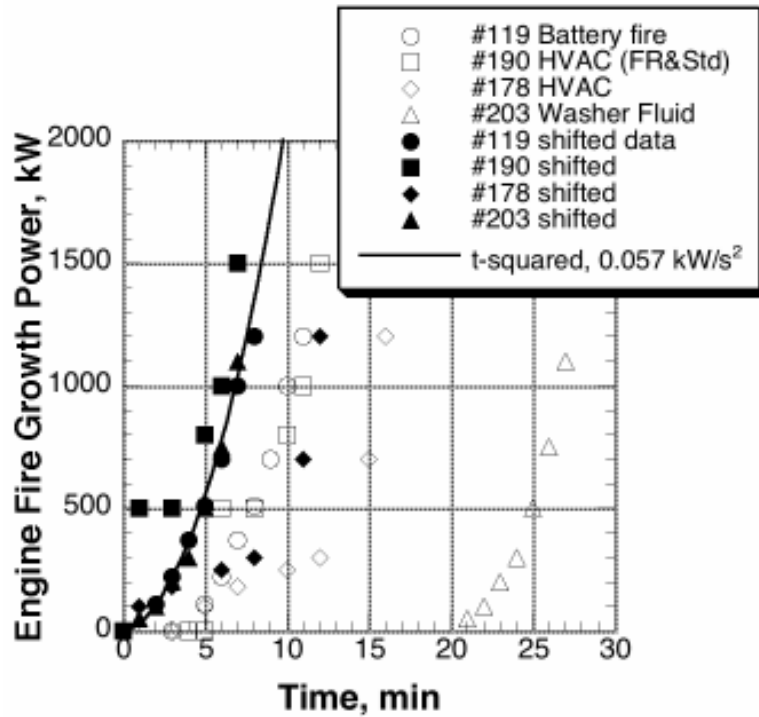
The rate of growth of the engine fires is shown in Figure 4-12.

Figure 4-12. Engine fire growth rate

As shown by the data in Fig. 4-12, significant growth was usually preceded by an “incubation period” that is typical and represents the small ignition fire involving other fuels. The incubation period depends on the vagaries of spread and is part of the randomness at reproducing fire growth. If the incubation period is adjusted out of the data, indicated by the filled symbols in Fig. 4-12, the actual growth rate can be assessed. To a large extent, the engine fire growth can be represented by a t-squared fire growth with a coefficient of 0.0057 kW/s². This corresponds to 420 s to reach 1 MW and can be classified as a “medium to slow” fire growth.

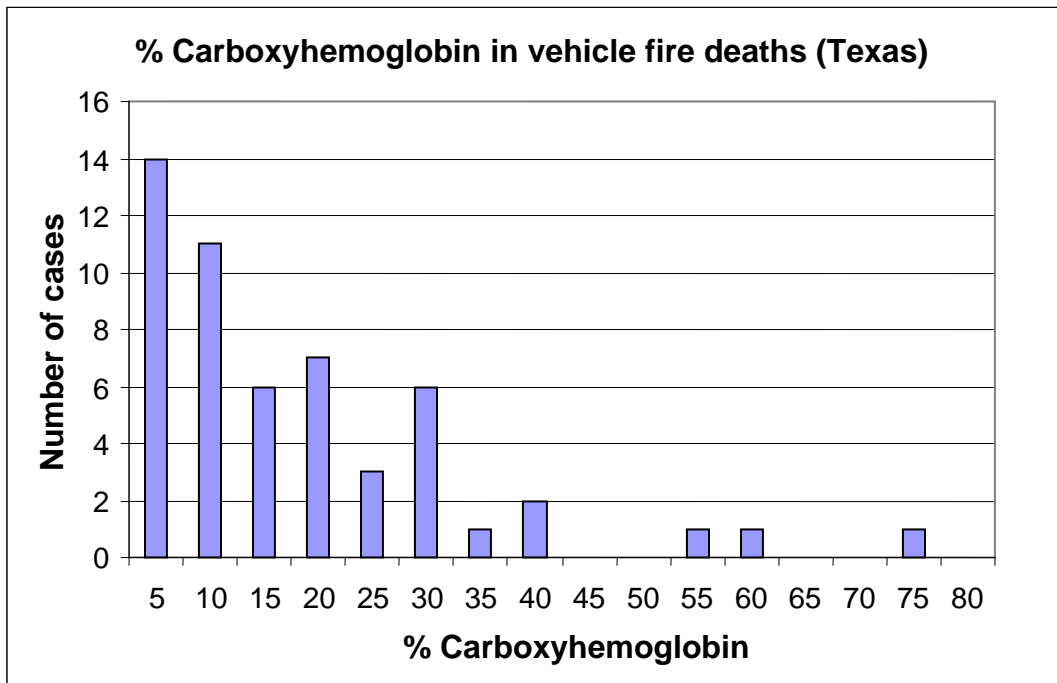
Figure 5-2. Percent carboxyhemoglobin in 53 vehicle fire fatalities from the Texas data for which fire could be identified as contributing to the causes of death (first set 0-5%, second 6-10% etc).

Figure 5-2 shows a similar plot of the %COHb in fatalities from the Texas post-crash vehicle fire data. The data consist of 53 fatalities for which fire is identified as a contributing to the causes of death and a small number for which the effects of fire are less certain. Cases where death was obviously a result of physical impact trauma have been excluded.

The results show three cases with %COHb concentrations sufficient to have caused death from CO poisoning alone, plus another three where CO might be considered a possible major factor. For nine cases showing levels between 20 and 30%COHb it is possible that asphyxia from the combined effects of toxic combustion products may have been a major cause of death, but other factors may have contributed. For the majority of cases with %COHb concentrations of less than 20%, it is likely that either physical trauma or heat and burns, or a combination of both were major contributory causes to death, possibly with some influence from inhaled toxic fire effluent.

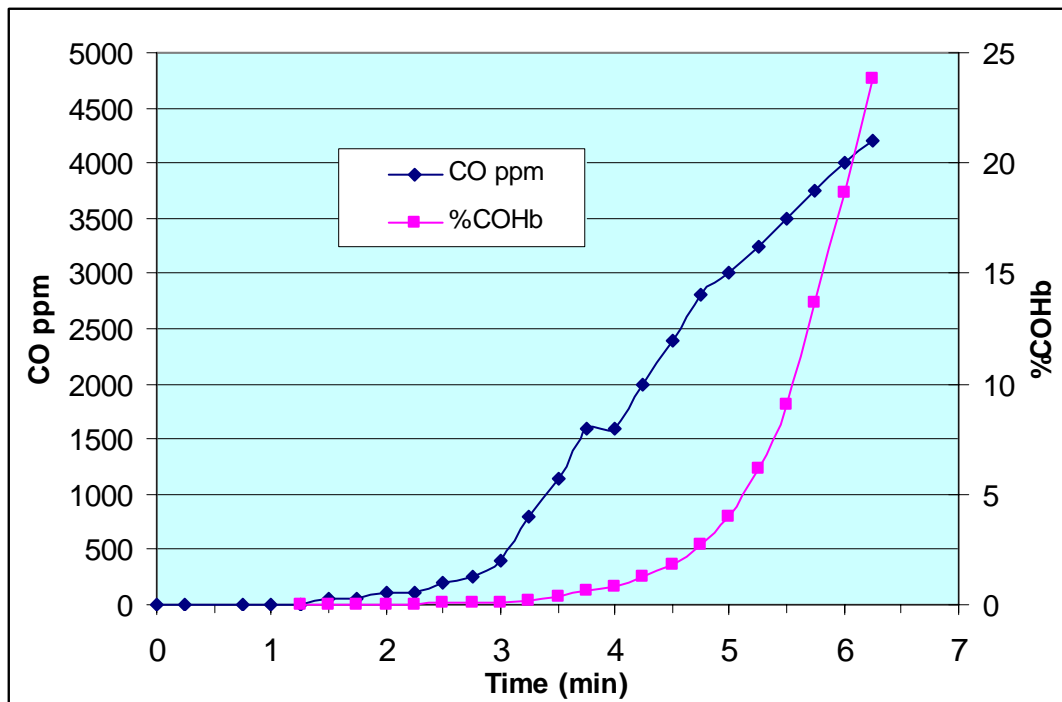
Figure 5-3: Measured passenger compartment CO concentrations and predicted %COHb for an exposed subject. Full-scale fire test report 6-189 Part 10 for Test #6. Mid-underbody gasoline pool fire 1998 Ford Explorer [8]

The predicted %COHb with time in the figures has been calculated based upon the CO and CO₂ concentrations measured in the cabin during these tests (using the method of Purser) [13]. The results show that once there is significant penetration of fire effluent into the cabin approximately 1-2 minutes are required for the predicted %COHb to increase by 1%. The subsequent increase depends upon the fire. For the more rapidly increasing CO level in the pool fire case 10% COHb is predicted after approximately 3.5 minutes exposure, while for the slower growing engine fire case the blood concentration is predicted to take approximately 7 minutes to reach around 5%COHb. For these examples the subject was assumed to be a 70 kg adult male with a resting respiration of 10 liters/minute (varied according to the CO₂ concentration during the test).

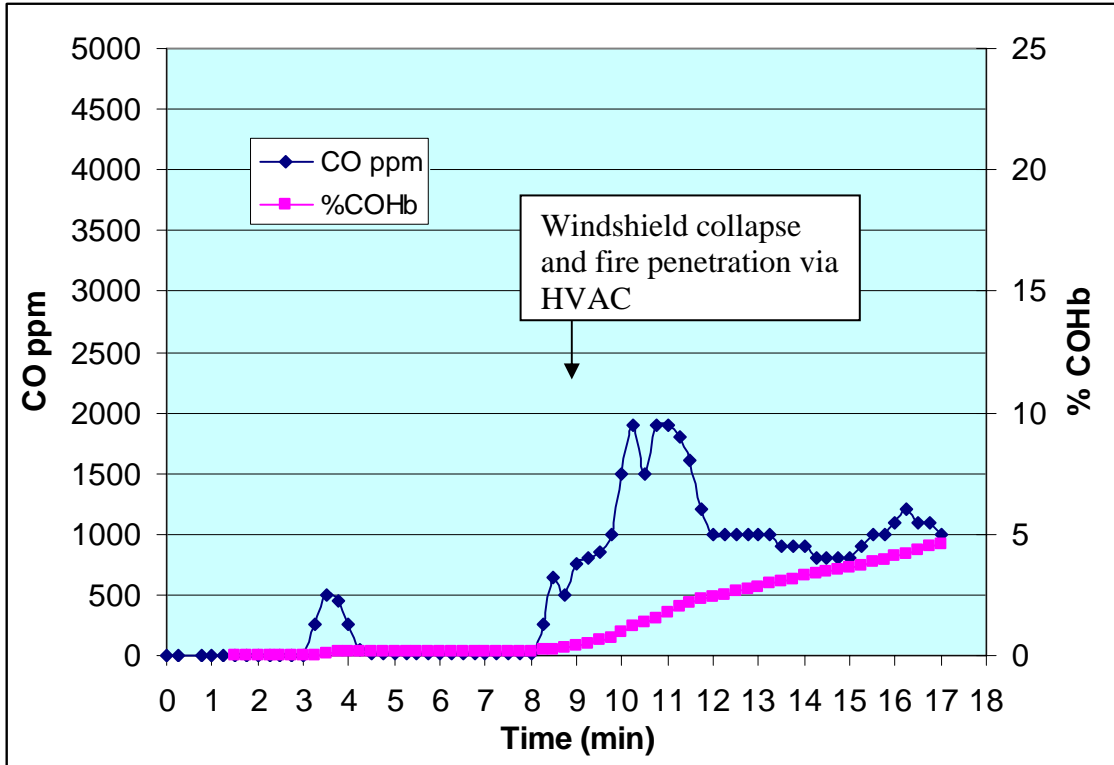
Figure 5-4: Measured passenger compartment CO concentrations and predicted %COHb for an exposed subject. Full-scale fire test #4 report 4-178 Part 7. Engine compartment fire 1997 Chevrolet Camaro [6].

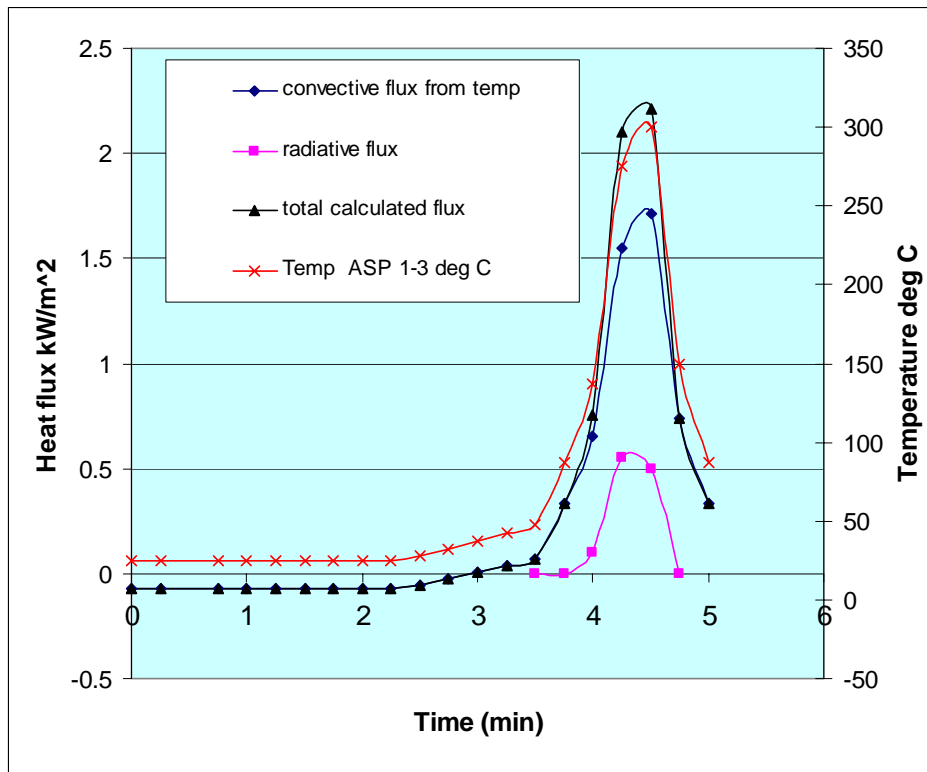
test, measurements were made for the temperatures, radiant flux and concentrations of products in the cabin. The temperature and radiant flux measured in the cabin in the cabin are shown in Figure 5-5. The data are averaged over 0.25 minute periods (using data read from the charts in the report). The convective heat flux has been calculated from the temperature and the sum represents the total heat flux to an occupant at approximately head height. The summed maximum value of 2.2 kW/m² between 4 and 4.25 minutes agrees well with the maximum total heat flux measured over this period by heat flux transducer.

Figure 5-5 Test 6-189 Part 10 [8]: Ford Explorer – gasoline pool fire: temperature, radiant and total heat flux in the passenger compartment

There is, however, a concern that at an average temperature of around 300°C, with high smoke particulate concentrations of 1354 mg/m³, the radiation from the hot smoke would be expected to be considerably more than the measured value of 0.6 kW/m². It is estimated that a flux close to 5 kW/m² may be more appropriate. It is possible that the effluent temperature at the radiometers may have been somewhat lower than that sampled by the aspirating thermocouple.

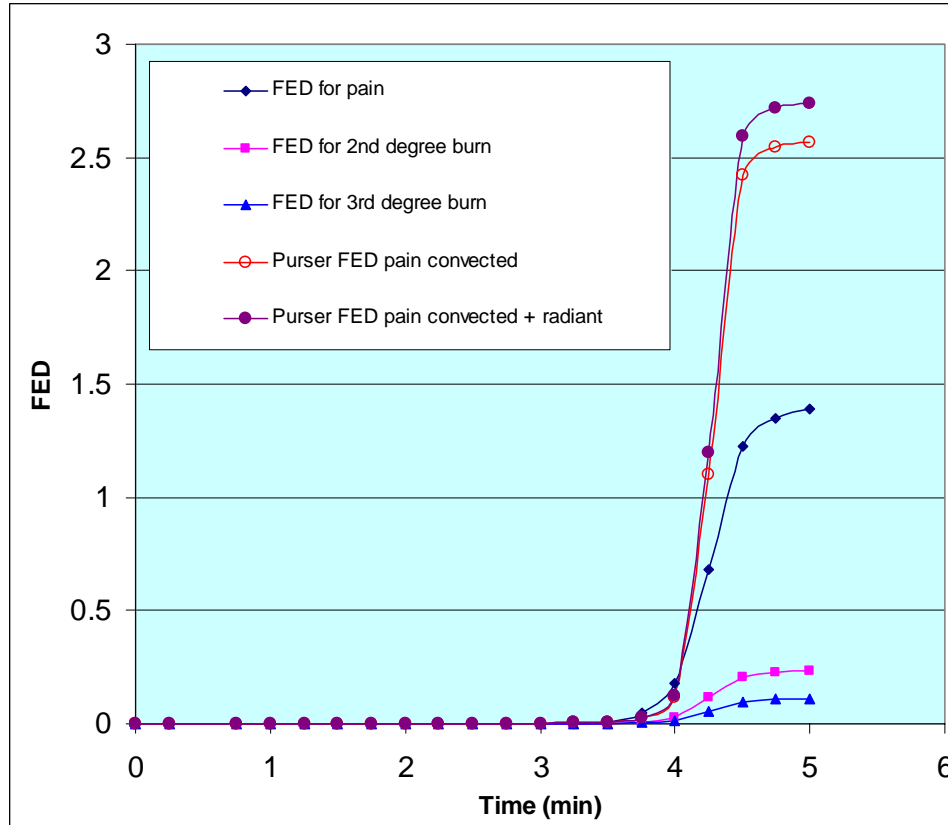
Assuming the heat conditions in the cabin were as shown in Figure 5-5, it is possible to estimate the effects these would have on a cabin occupant. The results of the application of several modeling approaches are shown in Figure 5-6. In the figure, heat exposure is treated as an accumulating “dose” of heat in the same way that toxic gas effects are treated.

Figure 5-6. Test 6-189 Part 10 [8]: Ford Explorer – gasoline pool fire: Fractional effective doses for heat parameters in the passenger compartment

Different heat exposure endpoints are predicted when the FED for that endpoint reaches 1.0. For the main method of analysis shown in the figure, the total heat flux to an occupant (radiant and convected) was calculated from the data shown in Figure 5-5. The heat dose required for different endpoints (pain, 2nd and 3rd degree burns) was as stated in Purser (SFPE Handbook 3rd edition) [13]. The threshold for pain is predicted at approximately 1.33-1.67 (kW.m⁻²)^{4/3}, second degree burns at 3-12.17 (kW.m⁻²)^{4/3} and third degree burns at 16.67 (kW.m⁻²)^{4/3}. Based upon this analysis it is predicted that a cabin occupant would experience pain to exposed skin from around 4.25 minutes, but that burns would not occur, since the fire is extinguished and the temperature

The other two curves in Figure 5-6 are for the FED equations published in the SFPE Handbook [13]. One is based upon empirical measurements of tolerance time for exposure to convected heat for human volunteers (after Blockley) [37]. This predicts pain at the same time as the other method, but the higher FED of 2.5 suggests that the pain may be somewhat more severe than that predicted by the method used for the first curve. The fifth curve represents the FED for pain due to radiation alone added to the FED calculated for convective heat. The first and fifth curves therefore represent two different approaches to estimating time to pain from exposure to convected and radiant heat. The differences illustrate the uncertainty inherent in assessing this endpoint, but in practice the predicted time to pain is very similar in both cases.

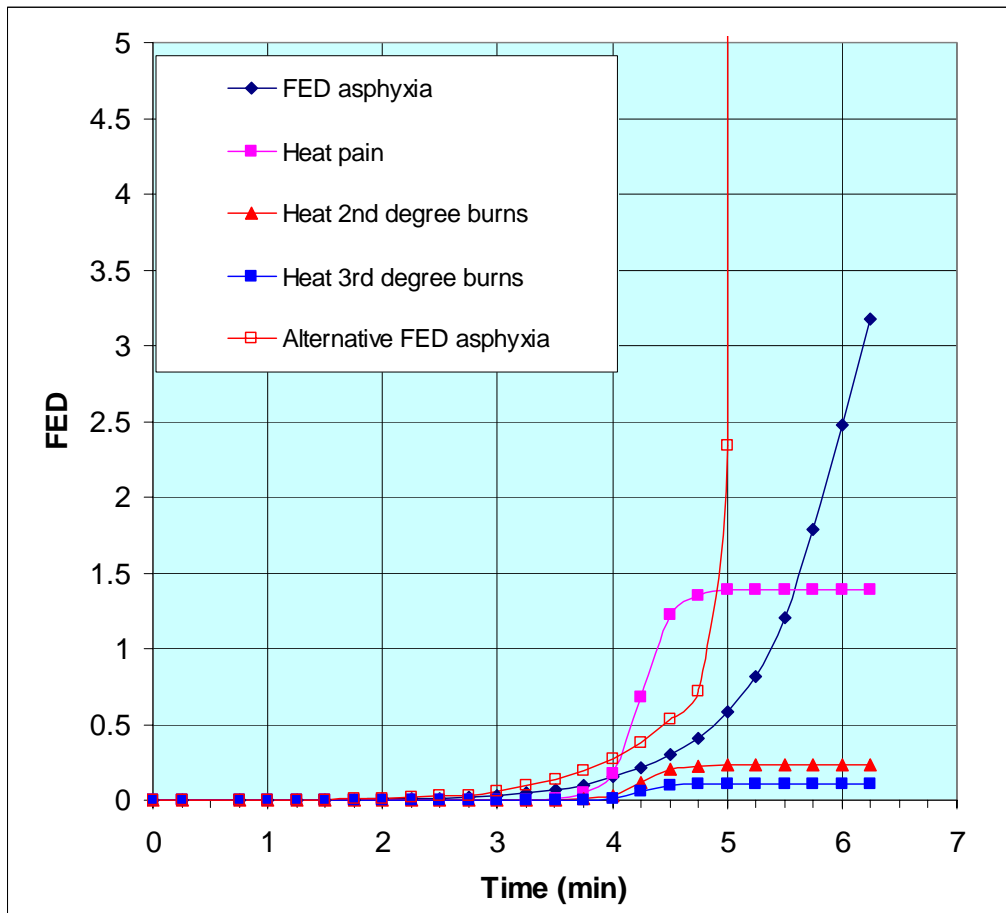
Figure 5-7 shows the results of the hazard analysis for the effects of asphyxiant toxic gases, compared to those for heat. The results are all expressed in terms of the fractional effective doses for predicted incapacitation (FED = 1) for each parameter. As with most fires, the first

Figure 5-7 Test 6-189 Part 10 [8]: Ford Explorer – gasoline pool fire: Fractional effective doses for toxic gases and heat parameters in the passenger compartment

A comparison of the predicted FEDs for asphyxia and for pain and burns from heat exposure is also shown in Figure 5-7. Based upon the analysis it is predicted that a cabin occupant would experience some pain to exposed skin approximately 0.5-1 minutes before losing consciousness due to asphyxia. However, burns are not predicted to occur.

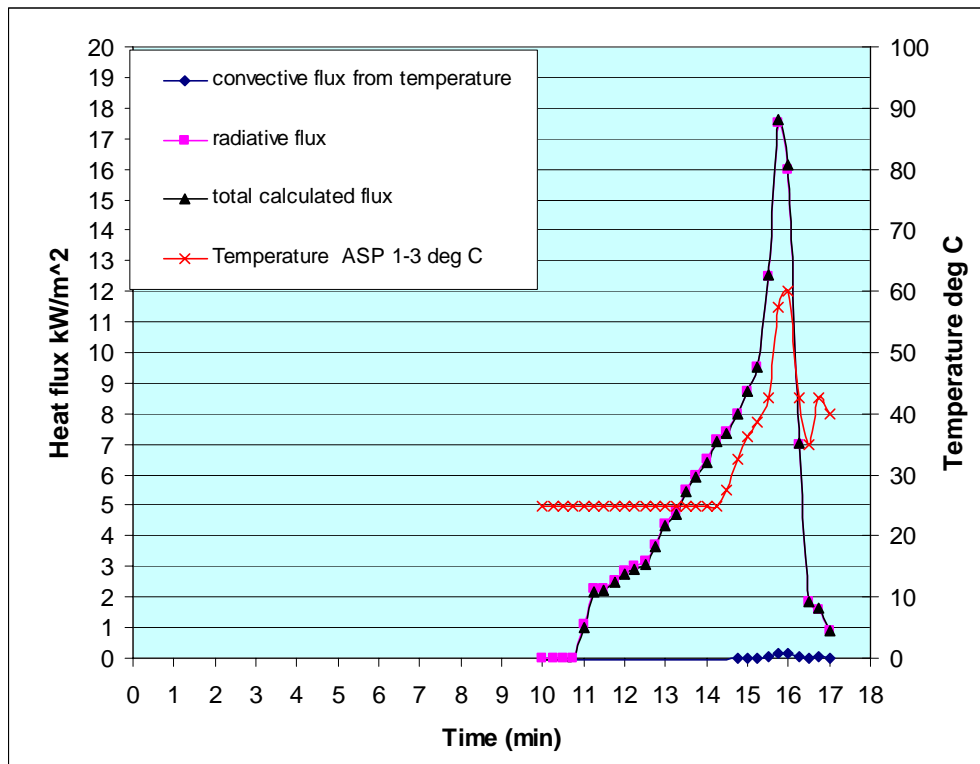
In Test #4, crashed 1997 Chevrolet Camaro was used and fire was started in the engine compartment [6]. Details of the test are described in Appendix B-4 and in Chapter III. In the test, measurements were made for the temperatures, radiant flux and concentrations of products in the cabin. Figure 5-8 shows the temperature, radiation and total heat flux estimated at the location of the drivers head. The convective component of the heat flux is very small, so that by far the major hazard is the radiation. This may be partly derived directly from the engine fire and partly from the growing fire inside the cabin in the dashboard area. This is in contrast to the Test # 6 for which radiation was a relatively minor component of the hazard up to the time the fire was extinguished.

Figure 5-8 Test 4-178 Part 7 [6]: Chevrolet Camaro engine fire: temperature, radiant and total heat flux in the passenger compartment

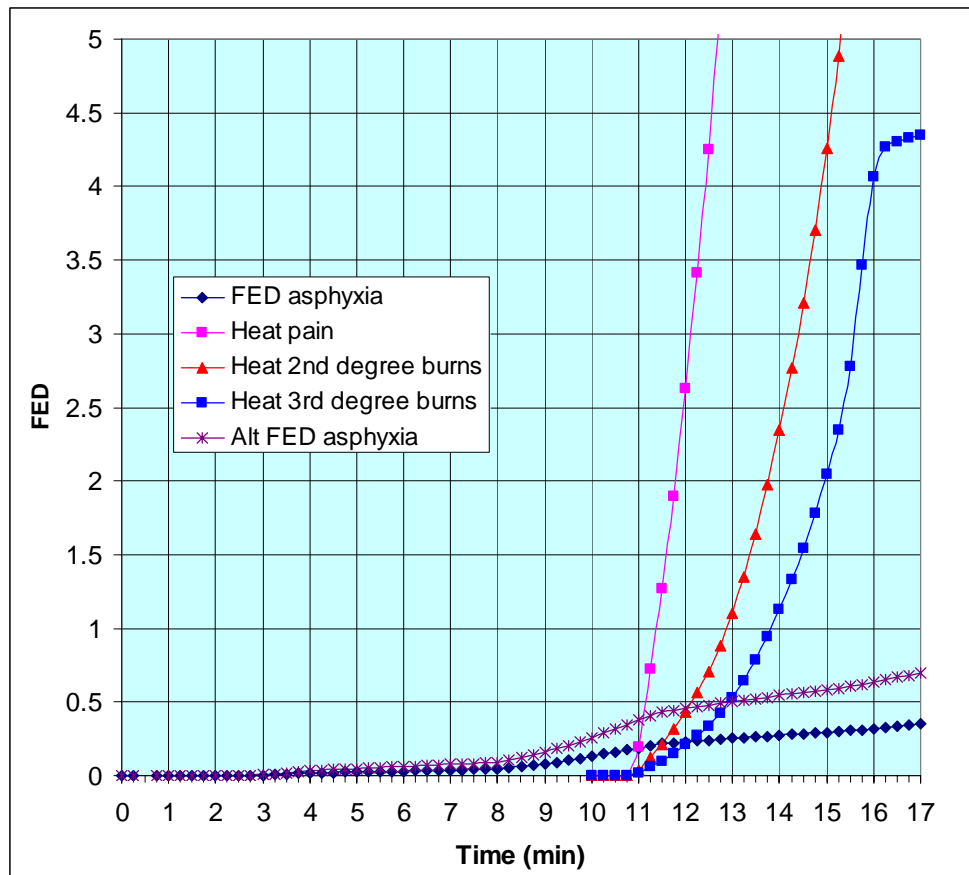
Figure 5-10 shows the FED analysis for asphyxiant gases for the crashed 1997 Chevrolet Camaro fire compared with the FEDs for heat and burns. From approximately eight minutes, an occupant would be exposed to a dense smoke containing significant concentrations of acid gas and organic irritants, but less so than for the 1998 Ford Explorer fire [8].

Figure 5-10 Test 4-178 Part 7 [6]: Chevrolet Camaro engine fire: Fractional effective doses for toxic gases and heat parameters in the passenger compartment

The levels are not considered to be seriously incapacitating, but would be expected to contribute to the breathing difficulties of an injured subject. Incapacitation in the form of loss of consciousness due to asphyxia is not predicted for this fire. At the time the fire was extinguished the predicted FED is less than half that required for incapacitation using the latest version of the Purser method and just over half using the most conservative alternative method. This is very similar to the results of the FAA combined hazard survival model and the older version of the Purser model used in the Test 4-178 GM Part 7 test report [6]. The review method gives a slightly higher FED value than that in the report because all gases were included whereas the Test 4-178 GM Part 7 test report [7], only CO was used. The other gases were considered to be below the thresholds for computation in Part 7 test report [7].

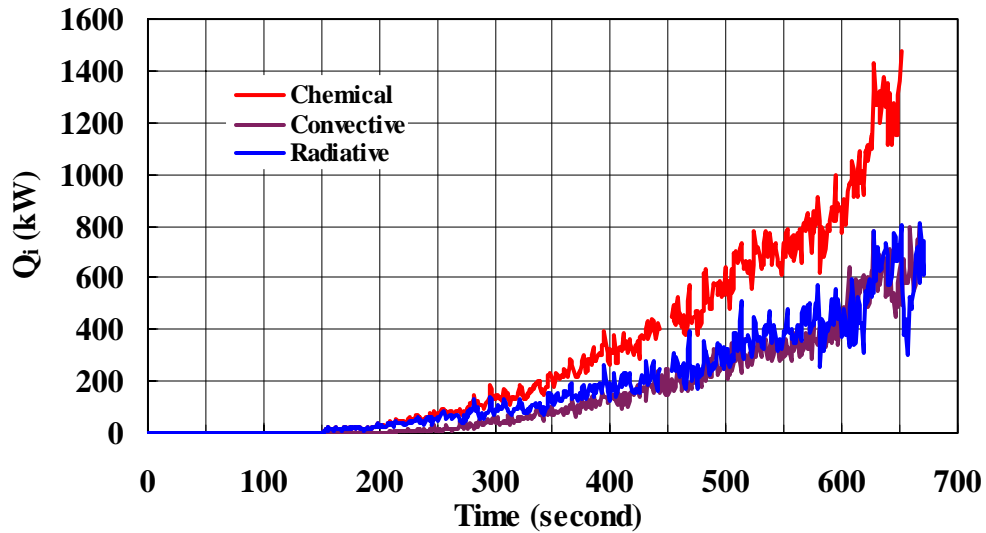
The heat release rate and generation rates of CO and CO₂ measured in the fire plume over the burning vehicle are shown in Figs. B-1-12 and B-1-13.

Figure B-1-12. Heat release rate measured in the fire plume over the burning 1996 Dodge Caravan. Data are taken from Ref. 1.
