TECHNICAL REPORT

Project ID 003018009

VOLUME I

POST COLLISION MOTOR VEHICLE FIRES

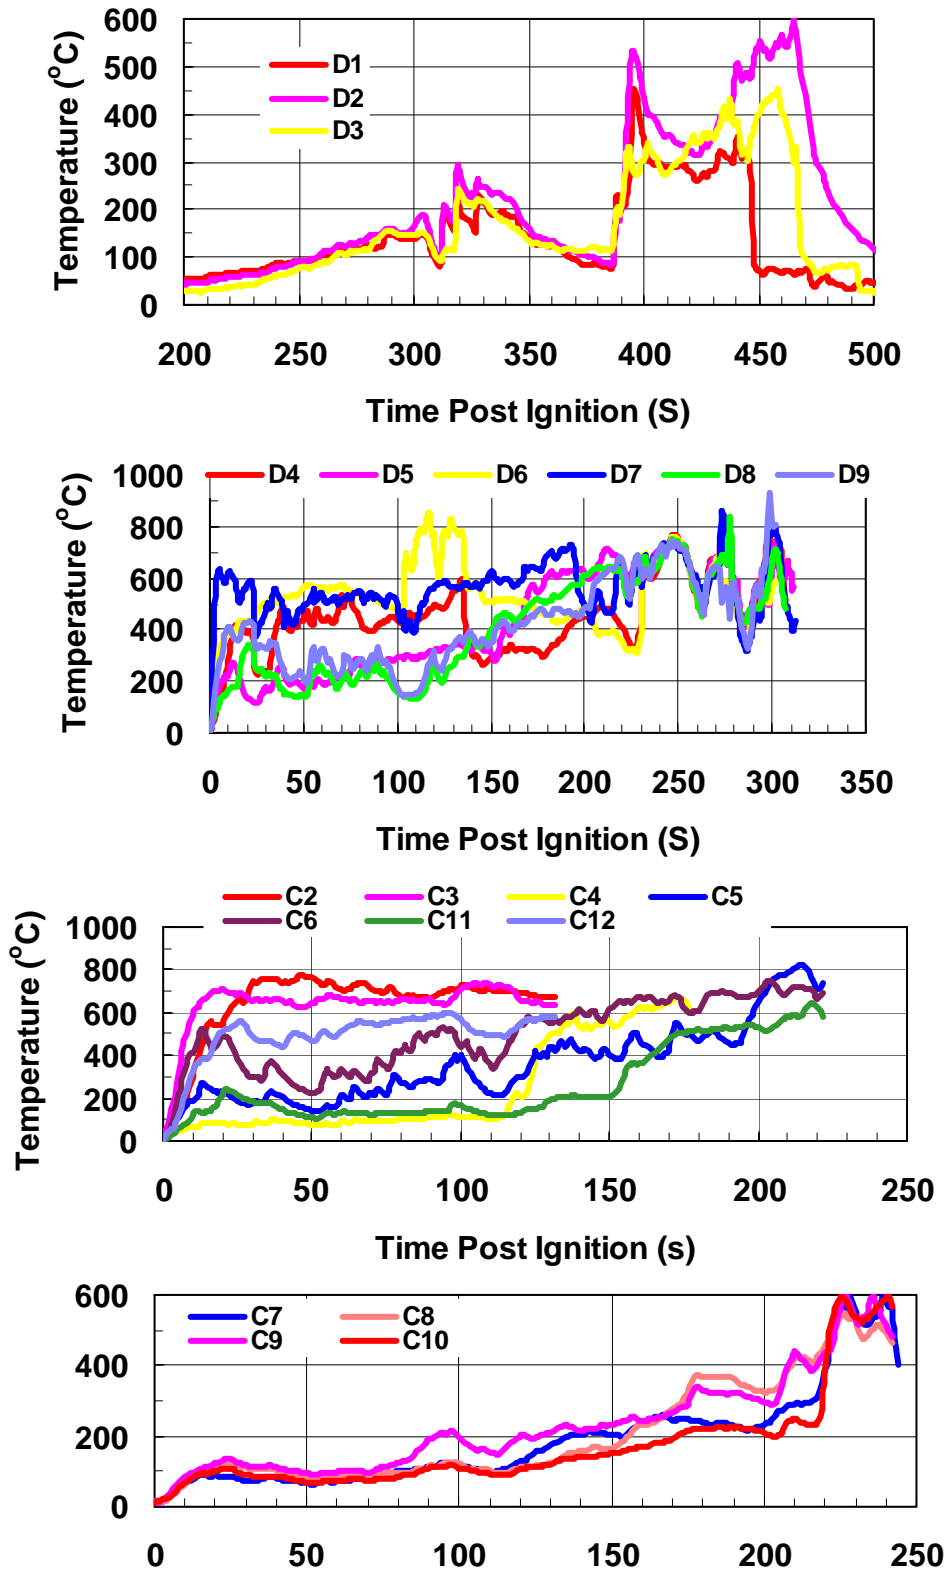
The fuel tank contained 38.5 liters (10 gallons) of gasoline at the start of the test. By 200 seconds post ignition, the fuel tank had lost about 833 ml of gasoline. At 213 seconds post ignition, there was an increase in the fire size at the left of the test vehicle, as solid materials (possibly rocker molding or the molding on the left) were burning and falling. At the end of the test, it was estimated that about 9.5 gallons of gasoline were present in the fuel tank. After the test, it was found that the exterior surface of the bottom of the tank was melted and charred, but interior surface was not melted or charred due to the cooling effect of gasoline. Two sections were missing from the bottom of the tank. The top the fuel tank also charred. The time-temperature relationships inside and outside the fuel tank and below the floor pan (D- and C-thermocouples in Figs. B-2-1 and B-2-2) are shown in Fig. B-2-3.

Figure B-2-3. Temperature versus time profiles for the inside (D1 to D3) and outside (D4 to D9) of fuel tank and 1-cm below the exterior of the floor pan in the burn test for the 1996 Plymouth Voyager. Data are taken from Ref. 2.

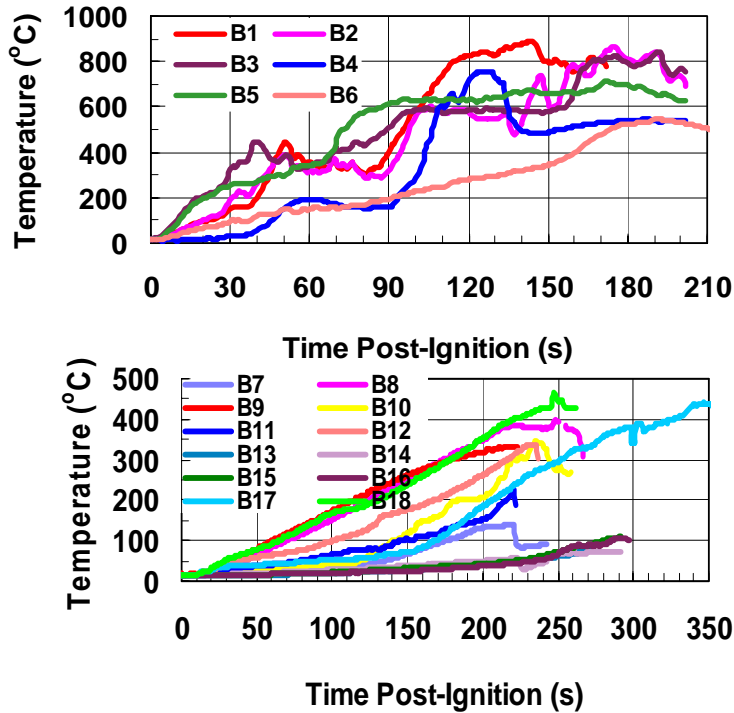
Figure B-2-6. Temperature versus time at the interior (upper) surface of the floor pan in the burn test for the 1996 Plymouth Voyager. Data are taken from Ref. 2.

The temperature time relationships for B locations are shown in Fig. B-2-6. The post ignition times to reach 30 °C, 50 °C, 100 °C, 200 °C, 300 °C, 400 °C, 500 °C, 600 °C, and the maximum temperature at B locations for the interior (upper) surface of the floor pan are listed in Table B-2-1 along with the temperature recorded at C locations. Maximum temperatures recorded at B locations are also included in the table.

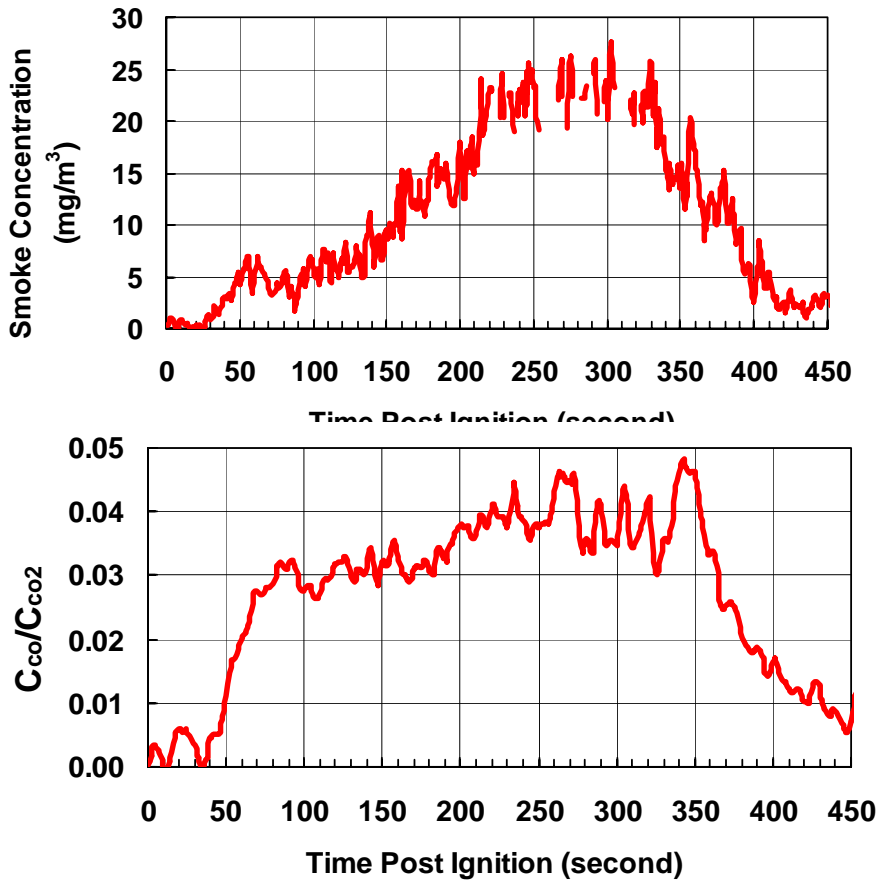
Smoke concentration and the ratio of CO to CO₂ concentrations are plotted in Fig. B-6-5. The maximum average smoke concentration in the plume, measured optically, is 22 mg/m³, whereas in the passenger compartment it reached a maximum of 1354 mg/m³ (Table B-6-3 and Fig. B-6-3).

Figure B-6-5. Smoke concentration and CO to CO₂ concentration ratio versus time in the plume of the burning 1998 Ford Explorer. Data are taken from Ref. 6.

The optically measured smoke concentration (Fig. B-6-5) is primarily the soot concentration in smoke, whereas the smoke collected on the quartz fiber filter consists of both soot and higher molecular weight organic and inorganic compounds. The GC/MS and IC data for smoke collected on the quartz fiber filter paper from the passenger compartment indicated that a large
